Highway Concrete Pavement Technology Development and Testing: Volume IV— Field Evaluation of Strategic Highway Research Program (SHRP) C-206 Test Sites (Early Opening of Full-Depth Pavement Repairs)

PUBLICATION NO. FHWA-RD-02-085

AUGUST 2006

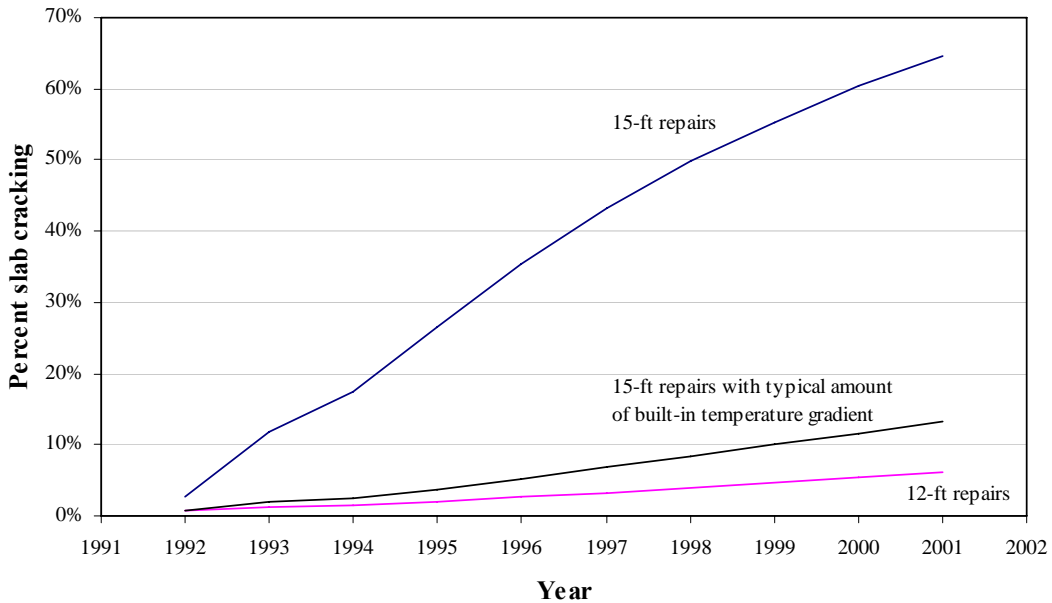
Figure 6. The effects of repair length and built-in curling on performance of full-depth repairs.

Figure 6 shows the effects of repair length and built-in curling on the fatigue performance of full-depth repairs. For bottom-up transverse cracking, the GADOT section represents the most adverse condition, because the repairs hardened with zero built-in temperature gradient.

However, even under this condition, the 3.7-m repairs have an expected fatigue life of 10 or more years; shorter repairs should have practically unlimited fatigue life. Figure 6 also shows that if moderate built-in curling were introduced, the fatigue life of the 4.6-m repairs would increase dramatically. In this example, a total effective built-in temperature gradient of $-5\text{ }^{\circ}\text{C}$ ($23\text{ }^{\circ}\text{F}$) was used, including the effects of temperature and differential shrinkage. This is a typical magnitude of built-in curling for PCC pavements in wet-nonfreeze climates. In general, for daytime construction, excessive built-in curling is more of a problem than is an inadequate amount of built-in curling.

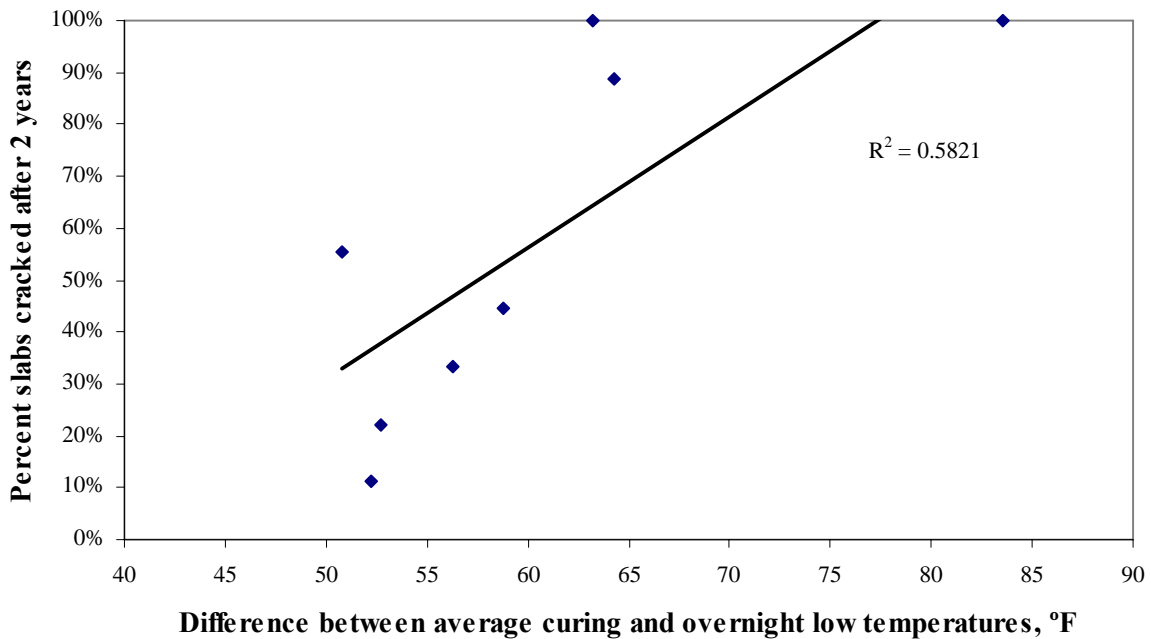
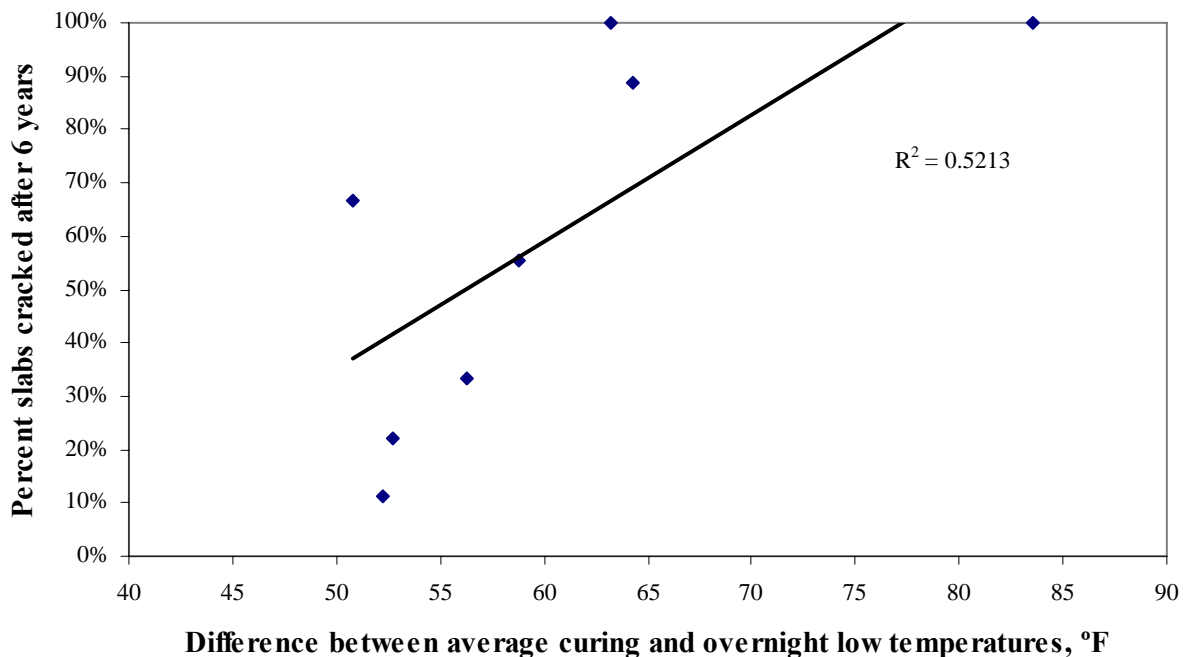
correlation between this parameter and longitudinal cracking in Ohio sections is shown in figures 10, 11, and 12 for the correlation at 2 months, 2 years, and 6 years of age. Figure 10 shows excellent correlation between this parameter and longitudinal cracking. If the cracking is caused by dowel restraint (of the horizontal movement in the transverse direction), this should be an effect that mostly influences the early-life behavior. Various factors would alleviate this effect at later ages, including creep and higher material strength. This is consistent with the trends shown in figures 10, 11, and 12. The best correlation is exhibited in figure 10 at 2 months of age, and the correlation becomes progressively worse for later ages.

The results shown in table 9 and figures 10 through 12 strongly suggest that the climatic conditions during construction played a major role in early development of longitudinal cracking in the Ohio sections. Figure 10 shows that if the difference between average curing temperature and overnight low temperature is less than about 10 °C (50 °F), the risk of developing longitudinal cracking due to dowel restraint is relatively low. That difference was less than 5 °C (41 °F) for all the Georgia sections, and none of the Georgia sections developed longitudinal cracking.

The risk of early age cracking can be evaluated using FHWA’s software HIPERPAV (McCullough and Rasmussen 1999; Forster 1998). The software takes key environmental, structural design, mix design, and construction inputs and generates a graph showing the development of PCC strength and stress over the first 72 hours after placement. If the stress exceeds the strength at any time, a high potential for uncontrolled cracking is indicated. For such cases, adjustments can be made to mixes, curing practice, or time of PCC placement to reduce the potential for cracking. Where a significant difference between the average curing temperature and overnight low temperature is possible (i.e., greater than 10 °C (50 °F)), the use of HIPERPAV is recommended.

- The temperature data from the Ohio site suggest that the risk of longitudinal cracking is high if the difference in average curing temperature and nighttime low temperatures exceeds about 10 °C (50 °F). The use of HIPERPAV is recommended in adverse conditions to avoid premature failures.

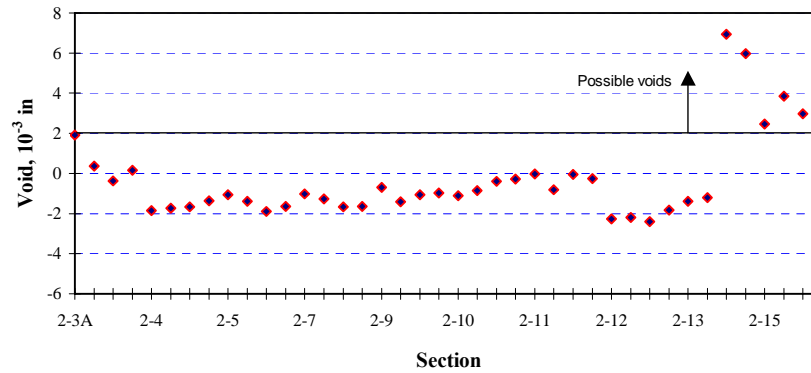
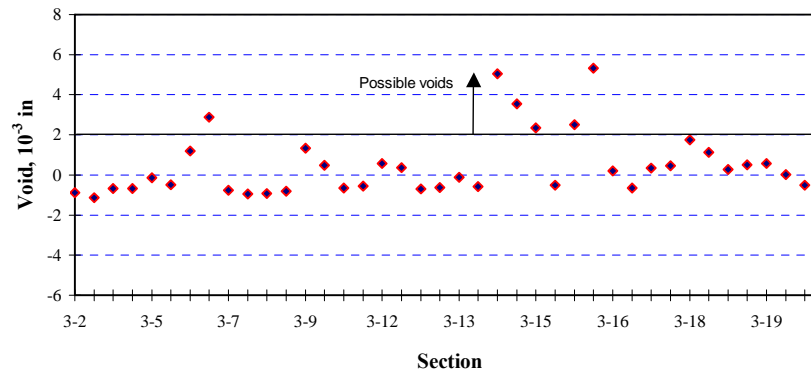
The intercept values from the load-deflection plots are shown in figures A4, A5, and A6. The figures show possible voids under the repairs 1-3, 2-13, 2-15, 3-13, and 3-15, but most joints tested show good support under the joints. These results show that the slabs were not curled up at the time of testing.
