2010

OBSI Testing of MnROADs I-94 WB Exposed Aggregate and Diamond Ground Test Sections

Preliminary Draft

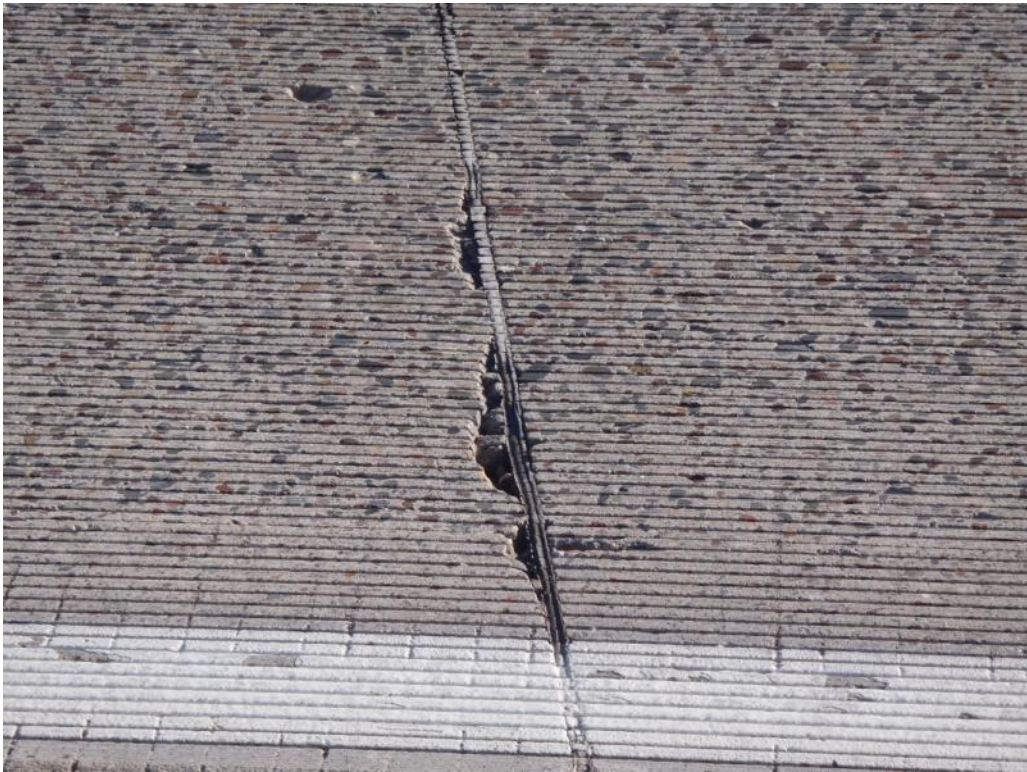
Figure 2-1 Spalling in NGCS LITE Texture (Cell 9)

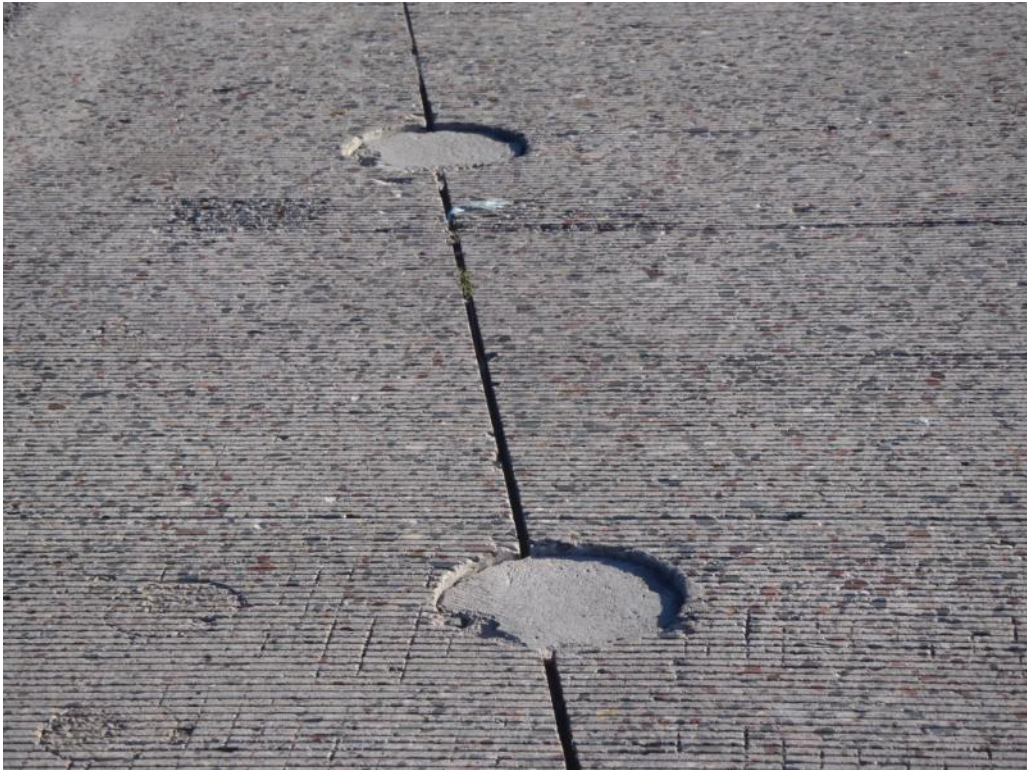
Figure 2-2 Depressed 12 inch Core Hole Repairs and Existing Transverse Tining

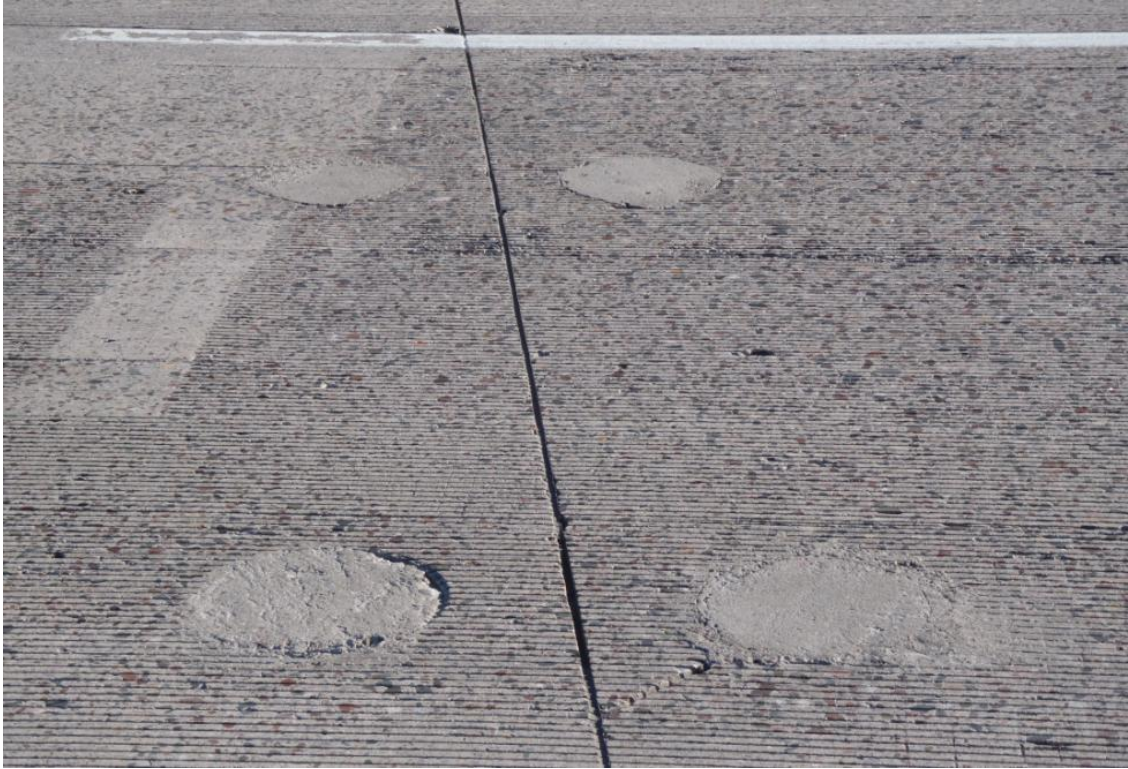
Figure 2-3 12" Core Holes with Good Patches

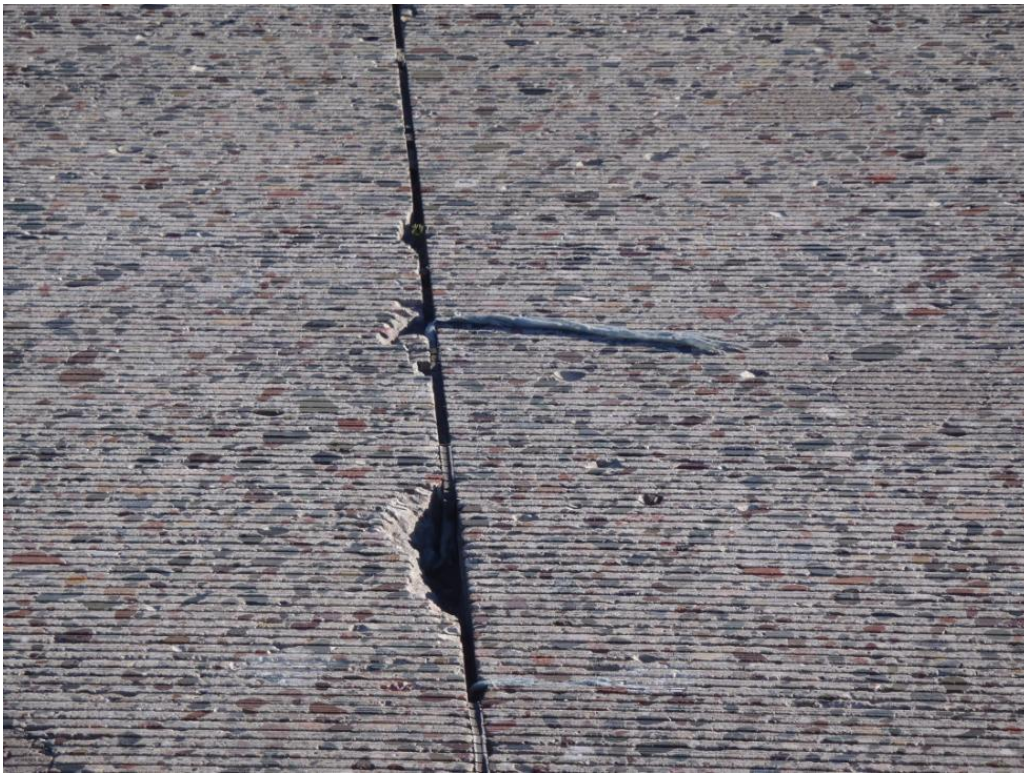
Photos of each of the test sections are included in Appendix 1 thru 5. It should be noted that the CDG, NGCS, and NGCS LITE sections, previously constructed on a 14 year old existing pavement, are exhibiting surface distress as indicated in Appendix 2 thru 5. The pavement distresses may be affecting the time series results. For the last two evaluations the tested wheelpath has been shifted to the left to avoid some of the potholes. However, it is also evident that the sealant continues to fail which can cause additional increases in measured levels which are not a result of changes in texture. For the Montecello sections backer rod was lying on top of the pavement surface at several joint locations in the EB direction.

Figure 2-4 Spalling at Joint and Backer Rod Exposed on Pavement Surface

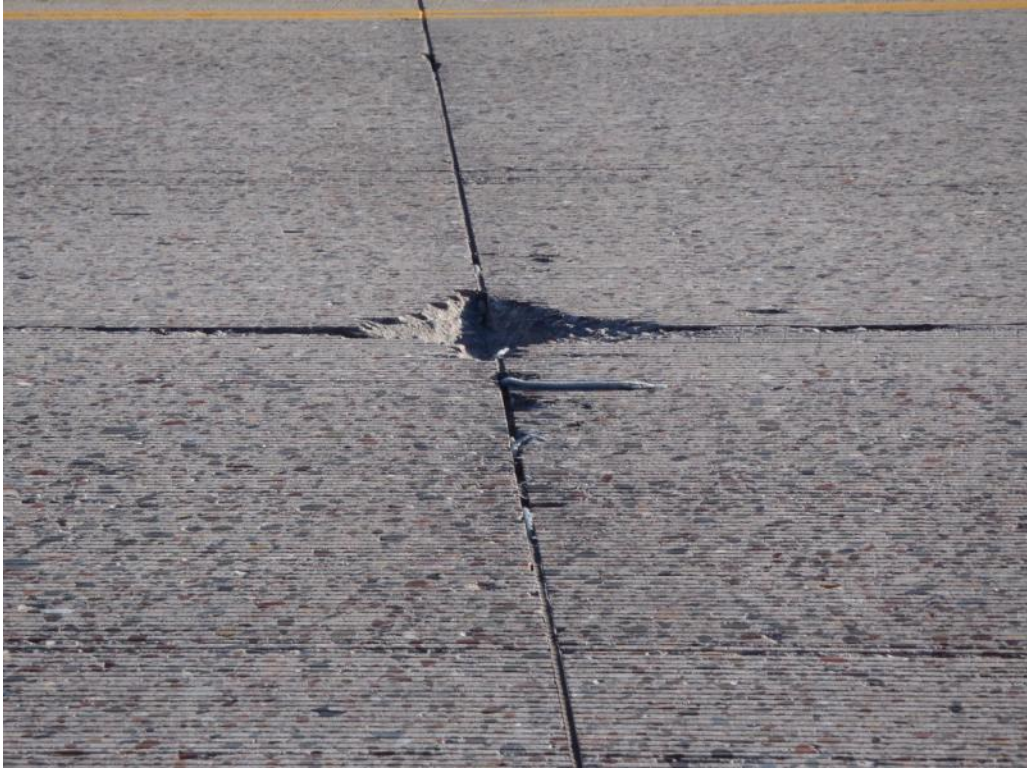
Figure 2-5 Spalling and Backer Rod Failure

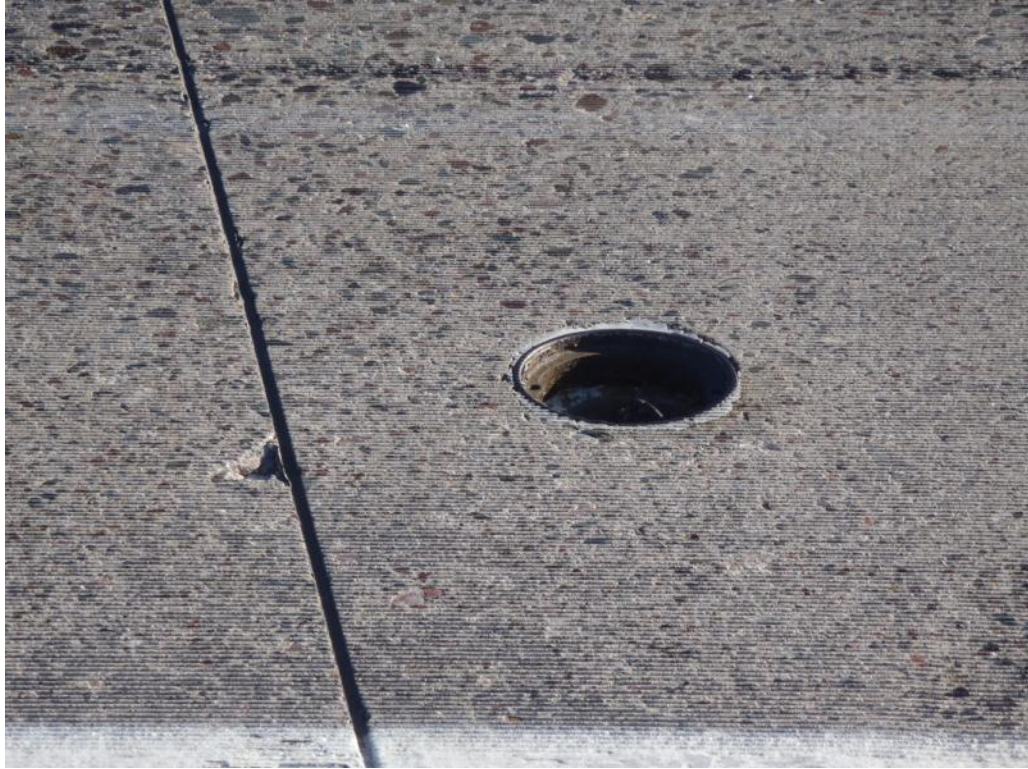
Figure 3-1 Hand Hole in Test Area

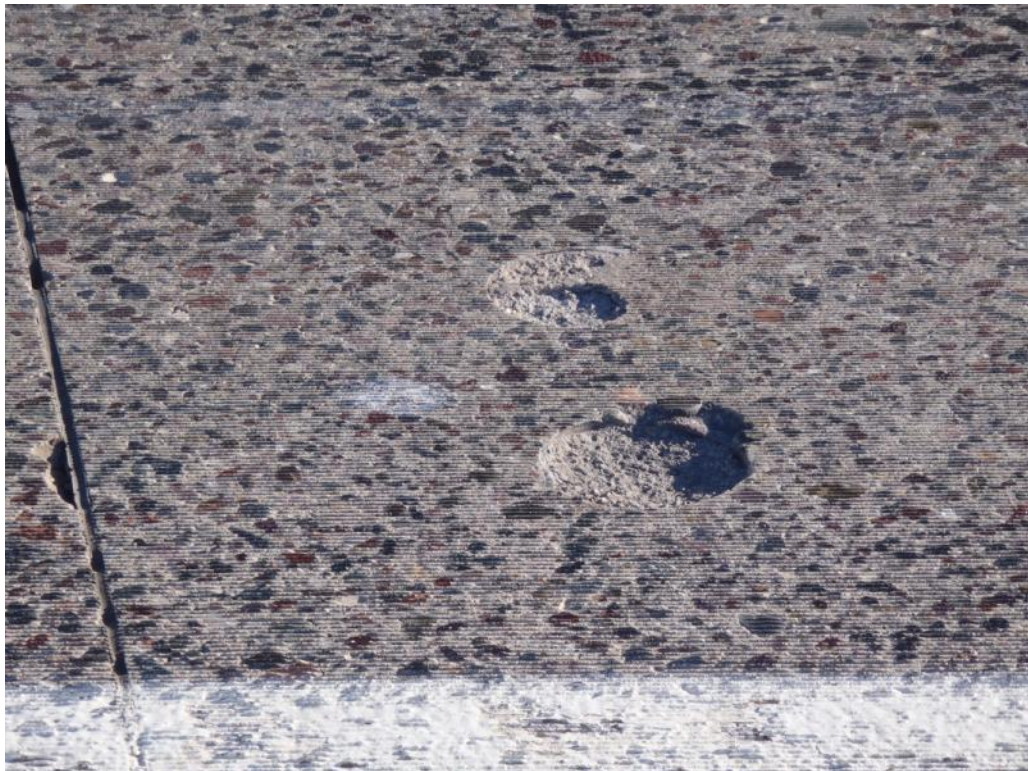
Figure 3-2 6" Core Hole Repairs

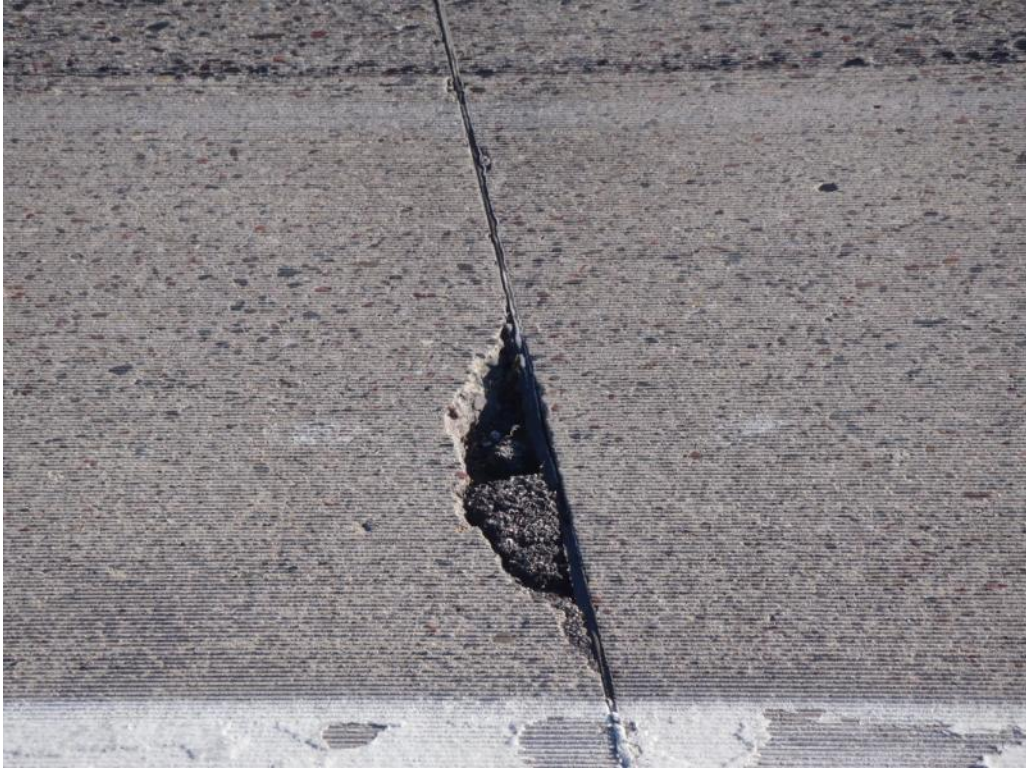
Figure 3-3 Spalled Joint and Failed Repair

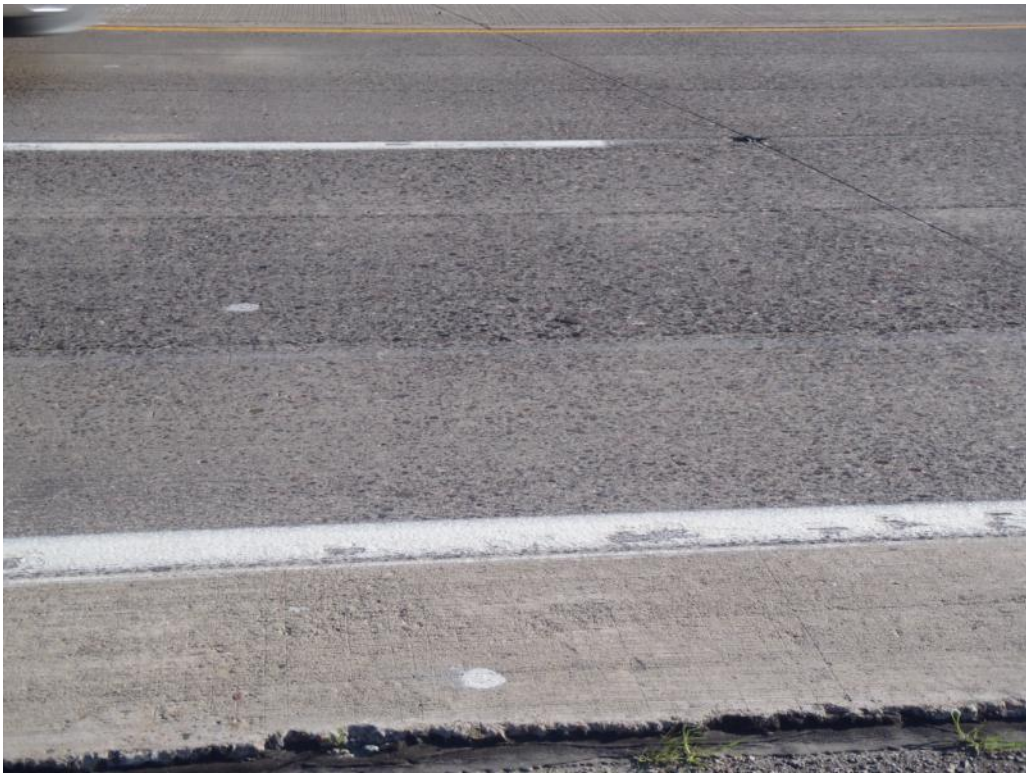
Figure 3-4 Texture in Outside Pass Appears Different

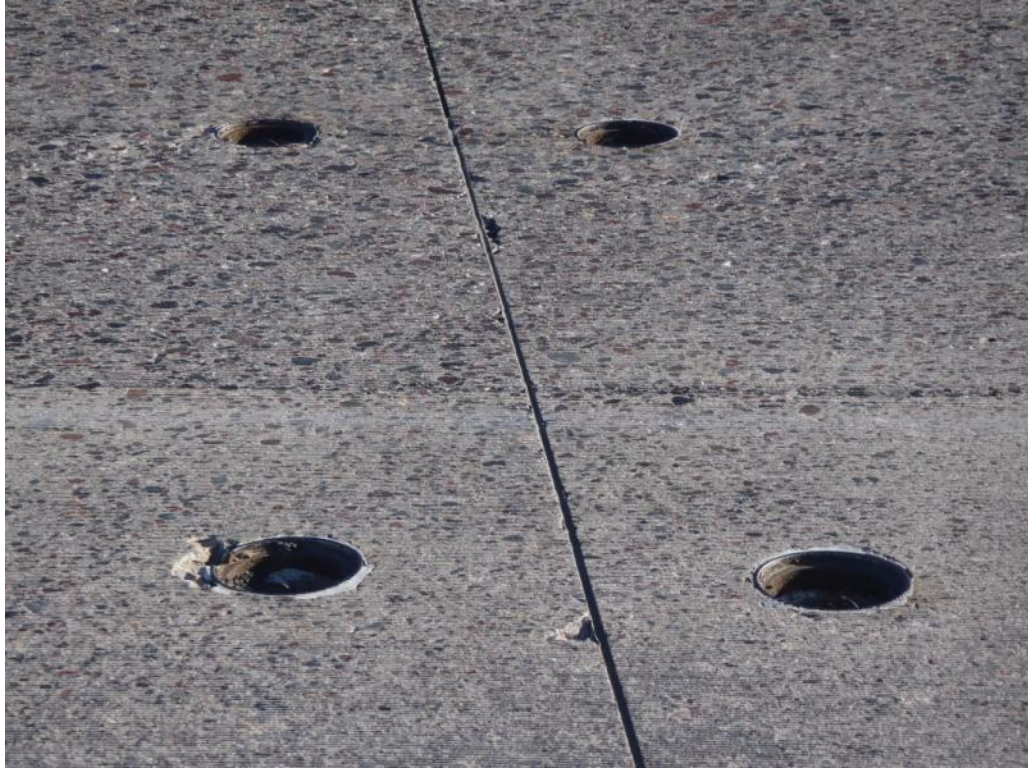
Figure 3-5 More Hand Holes in Section

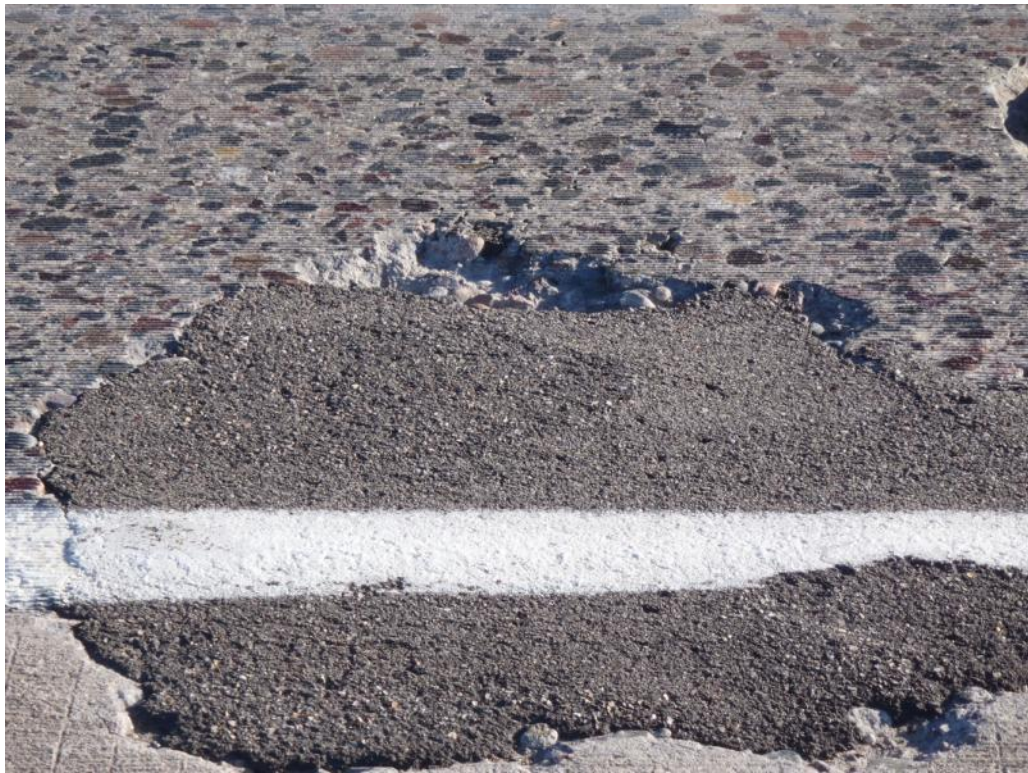
Figure 3-6 Pot Hole Repair at Edge of Pavement

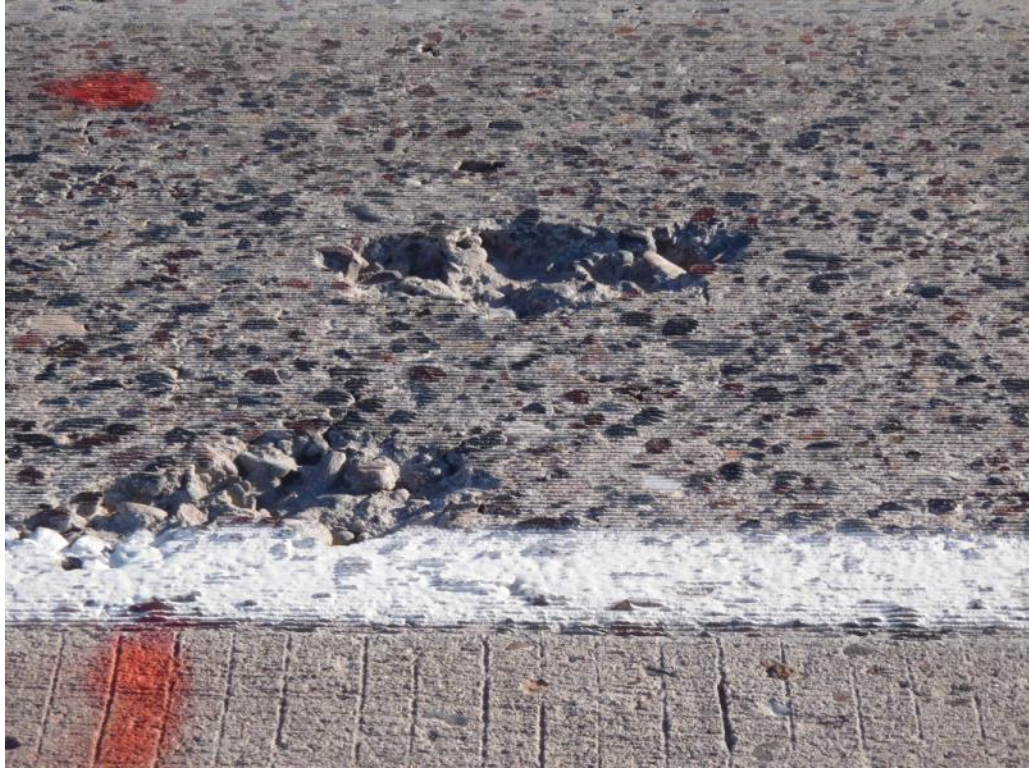
Figure 3-7 Spalls on Surface of Roadway

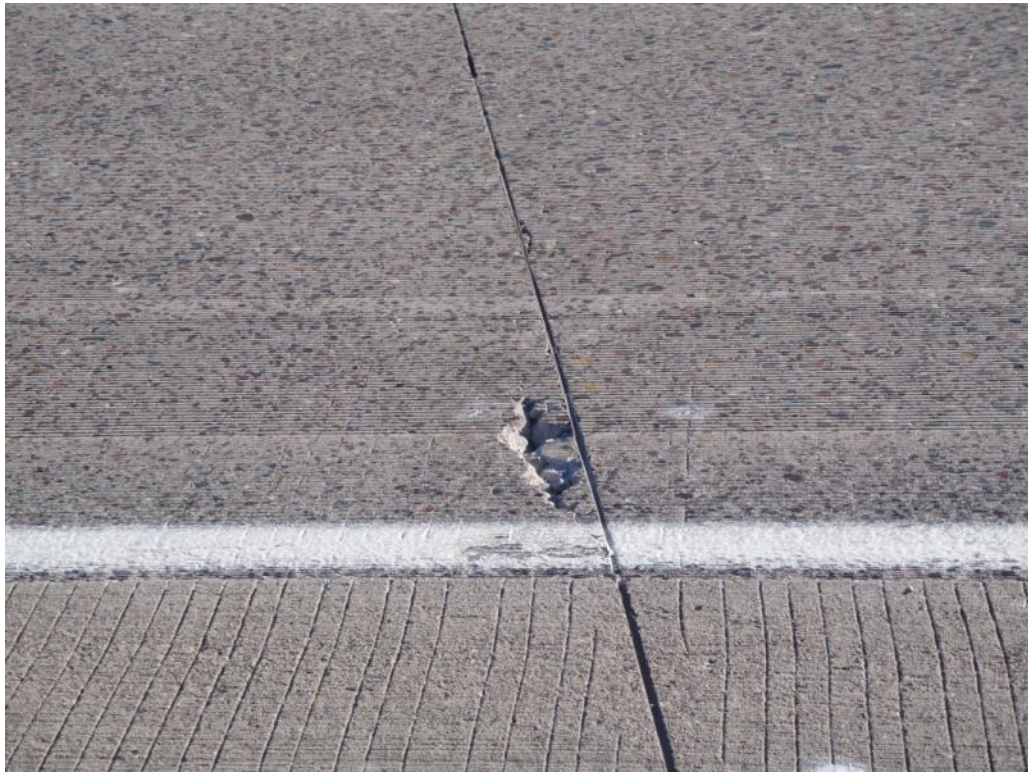
Figure 4-1 Spalling at Joint

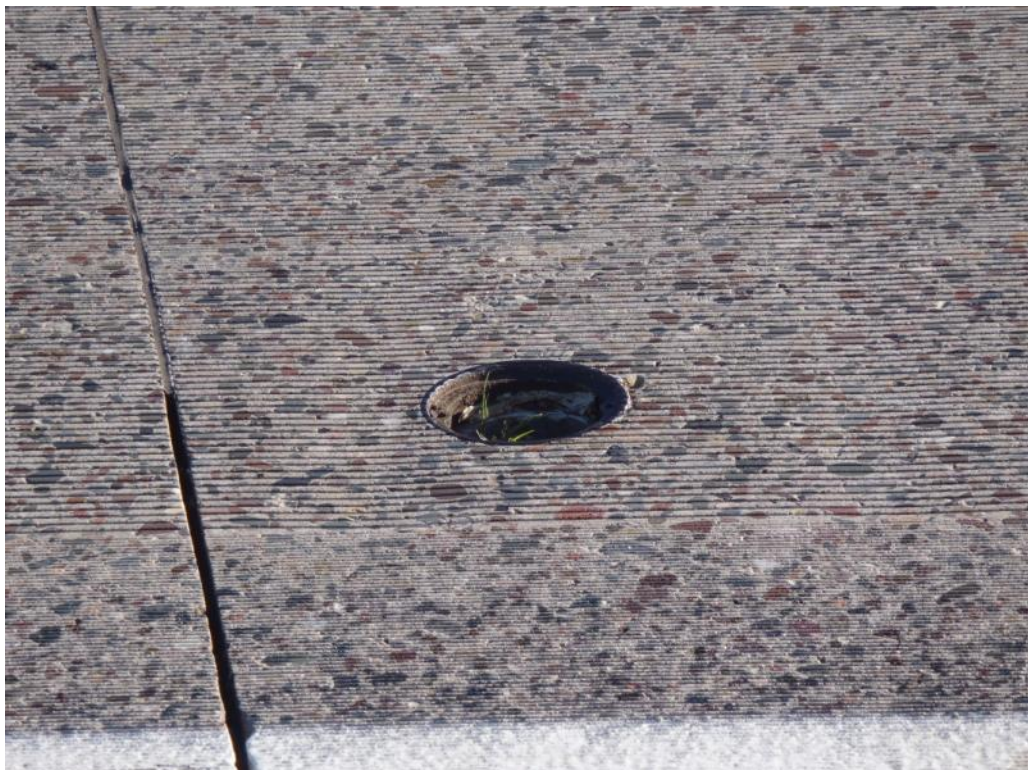
Figure 4-2 Hand Hole with Grass and Sealant Failure in Transverse Joint

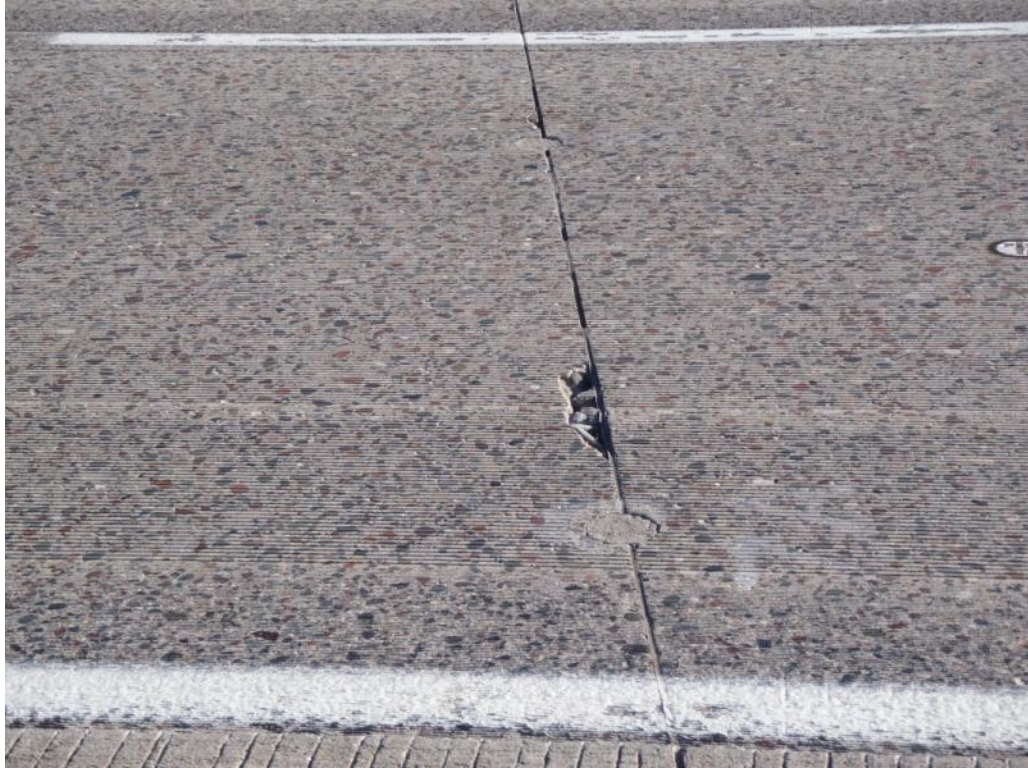
Figure 4-3 6" Core Hole Repairs and Spalling at Joint

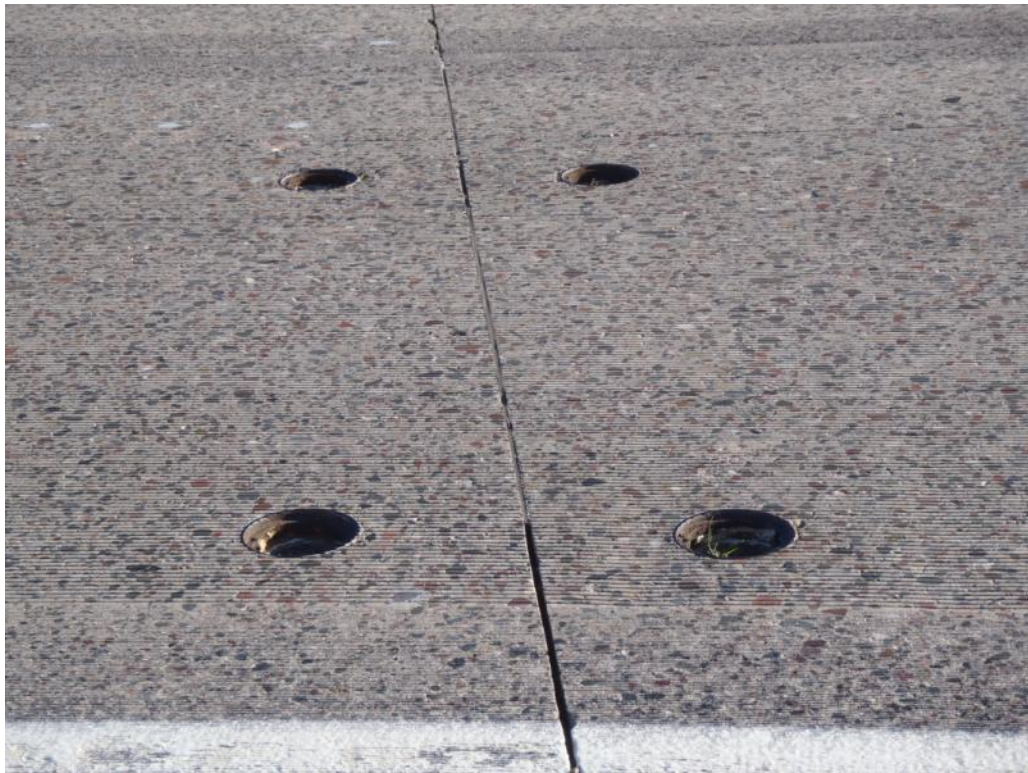
Figure 4-4 Hand Holes in Pavement

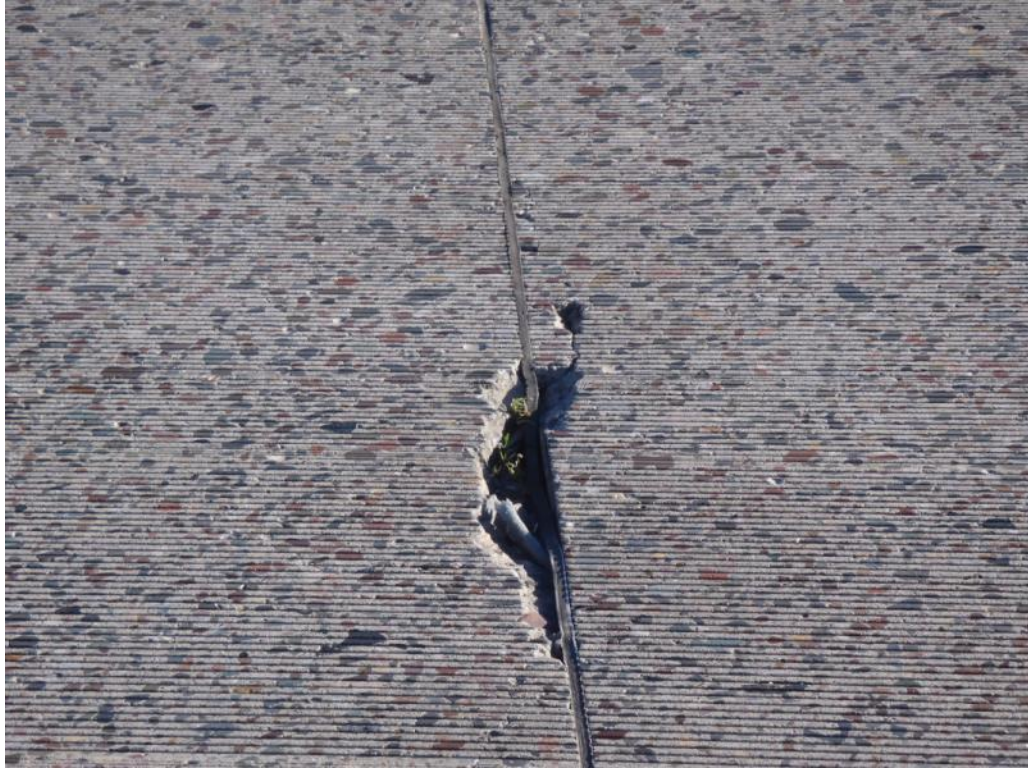
Figure 4-5 Spalling at Joint

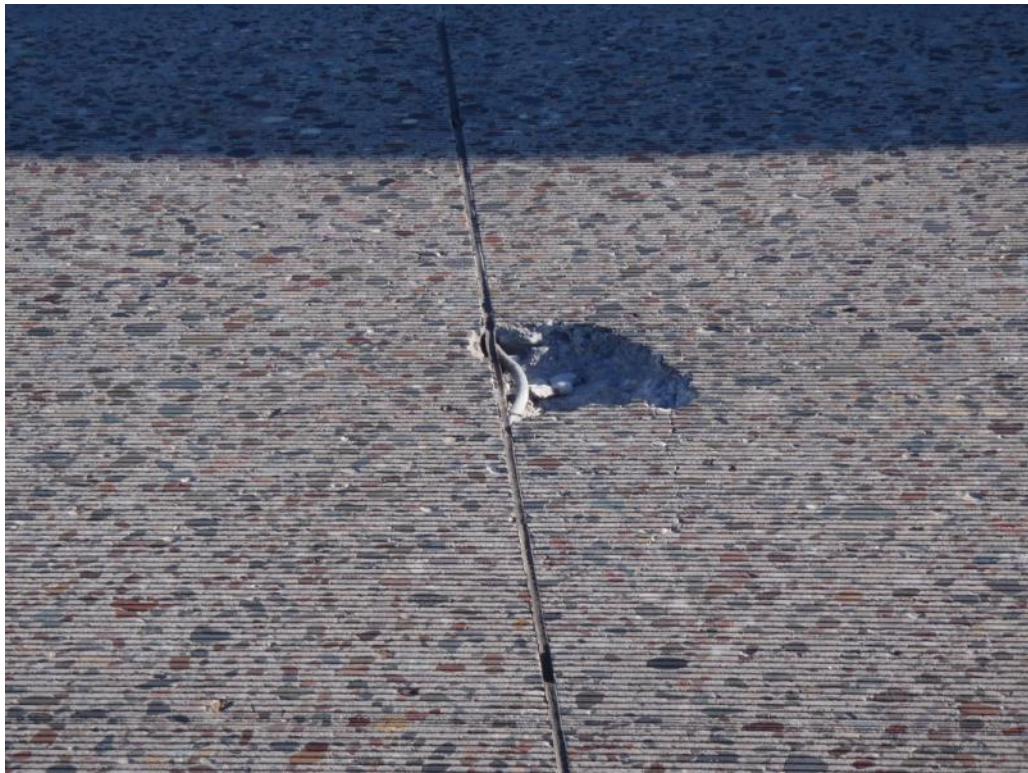
Figure 4-6 Spalling at Joint

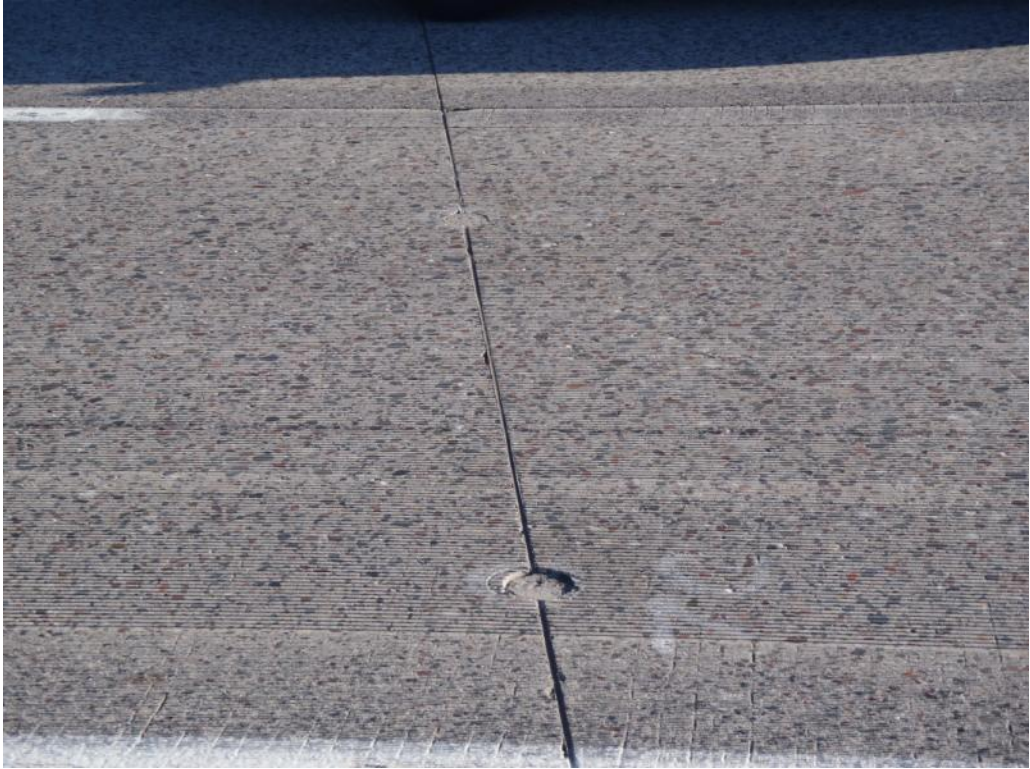
Figure 4-7 6" Core Hole Depression

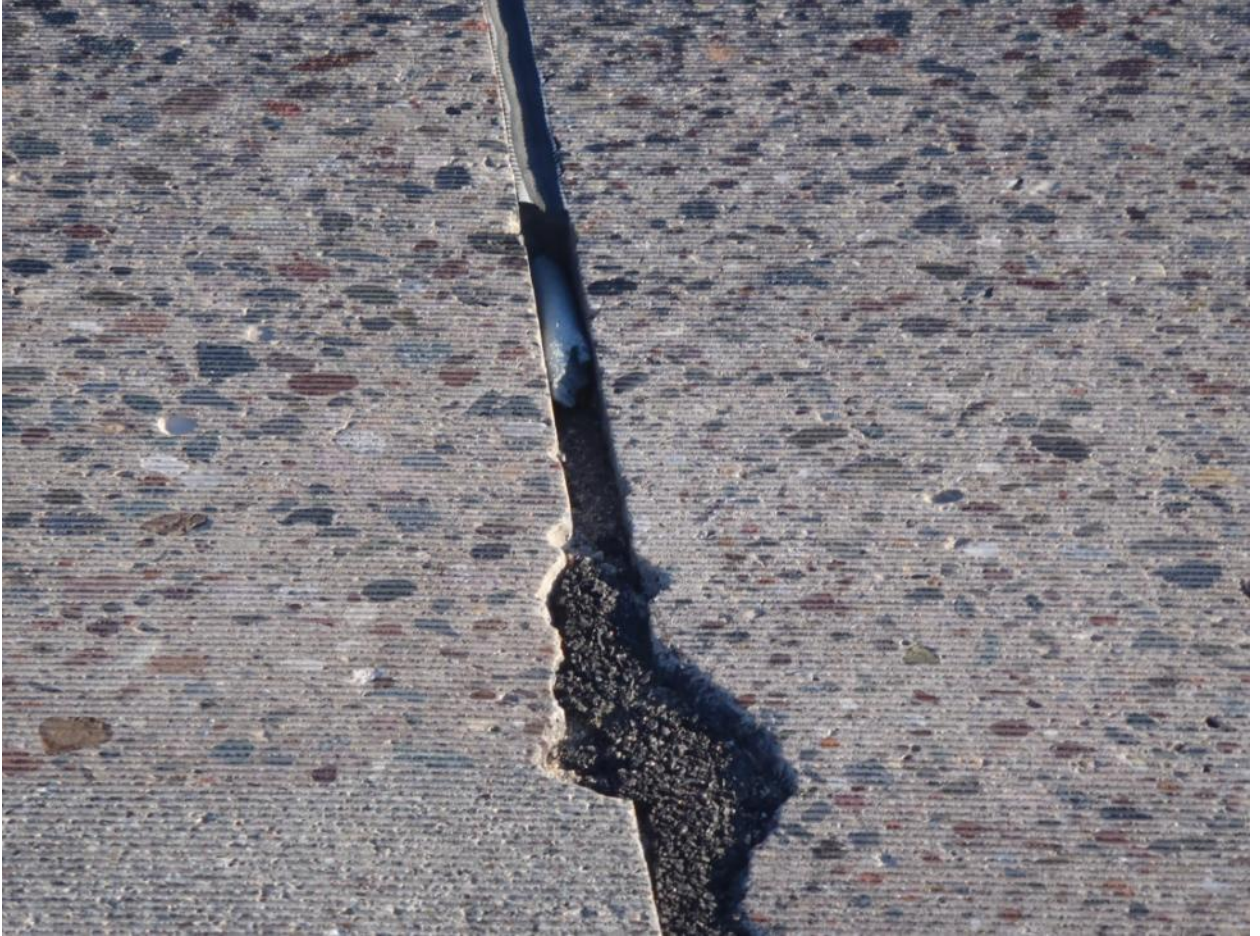
Figure 5-1 Spalled Joint and Failed Sealant in Wide Joint

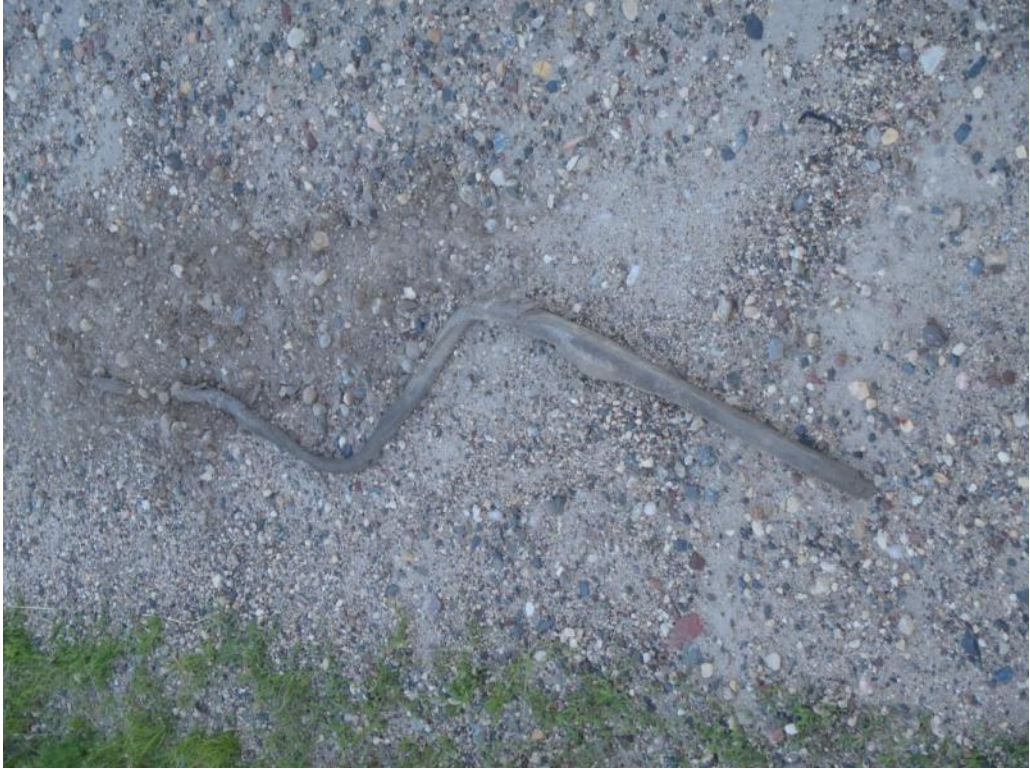
Figure 5-2 Failed Sealant on Shoulder of Roadway
