**Pilot Study on Direct Discharge of Concrete Grinding Residuals to Roadside  
Shoulders: Part 2 (TAR 2017-2&3)**

Daniel E. Line, PE

November 8, 2016

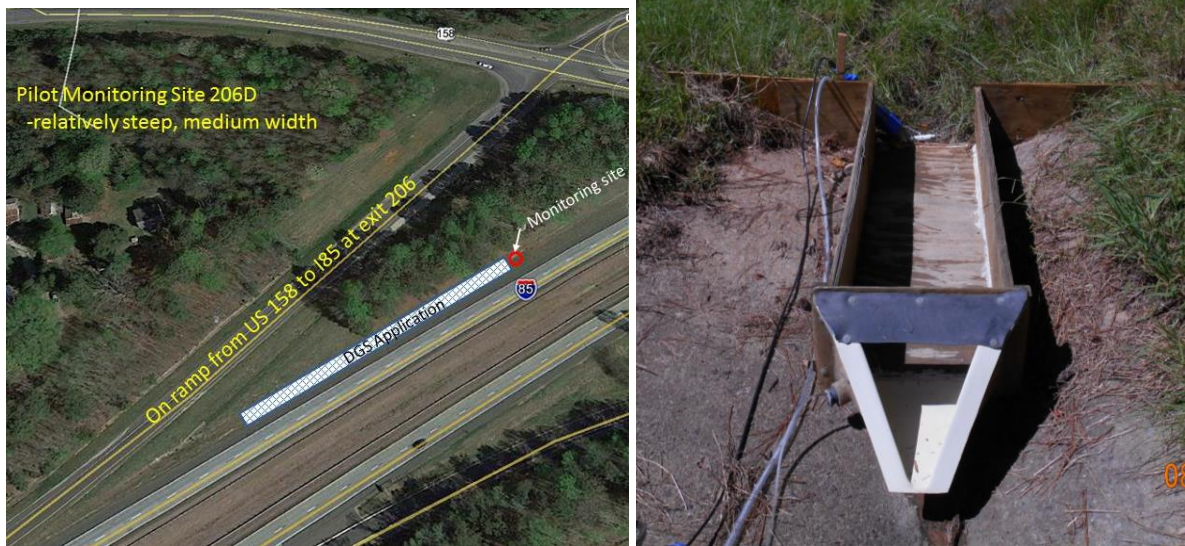
Figure 2. Site 206D aerial view (left) and flume (right).

This project was conducted in conjunction with the NCDOT pavement preservation project I-5787 (C 203765) on I-85 just north of the intersection with NC 56 in Granville County to just north of the Vance County line (figure 1). The north and southbound exit ramps along I-85 provided the safest places to set up research equipment and to monitor the diamond grinding operation; therefore, each monitoring site was along the I-85 shoulder within the on and off ramps of an exit. Several sites at exits along I-85 were evaluated for possible inclusion in this pilot study. The sites selected were labelled using the exit number where they were located. Site characteristics such as soil pH, slope and length of the shoulder, and extent of the drainage area were used to evaluate the suitability of the site. The intent was to find a site representing a worst case (narrow and steep shoulder to roadside ditch), a best case (wide shoulder with gentle slope to roadside ditch), and a control that was somewhere in between. The worst case site (Site 206D) was located along the shoulder of I-85 within the southbound on-ramp from US 158 to I-85 (figure 2). The best case site (Site 204C) was located within the southbound off-ramp from I-85 to NC 96 (figure 3). The control was located within the northbound off-ramp from I-85 to NC 96 (figure 4). A vertical tillage tool was used to loosen the soil on the shoulder of I-85 at Site 206D (figure 5). When DGS was applied it tended to accumulate in the furrows left by the tool as shown in figure 5. At site 204C the soil surface on the shoulder was left undisturbed.

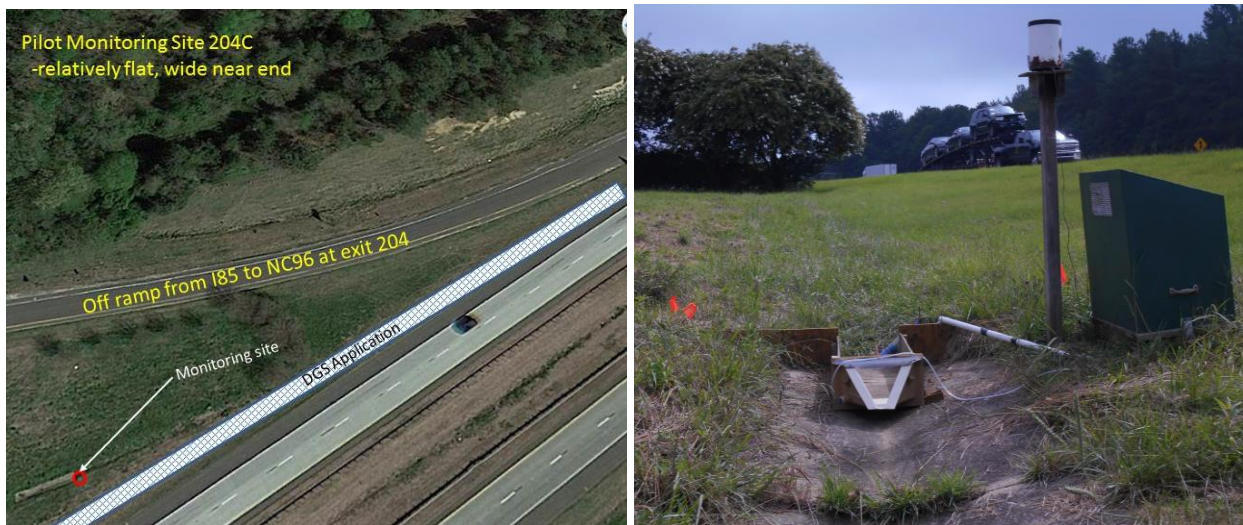
Figure 3. Site 204C aerial view (left) and monitoring station (right).

At each of the three sites selected, a 0.75 ft flume with a 4 ft approach section was installed in the drainage channel. Plywood wingwalls (figure 3 right) were also installed at the inlet to each flume to direct all of the runoff in the ditch through the flume. An automated sampler with integrated flowmeter was installed next to each flume to record runoff/discharge and collect flow-proportional samples during storm/runoff events. Samples were analyzed for pH, total suspended solids (TSS), total phosphorus (TP), calcium (Ca), magnesium (Mg), and lead (Pb). In-situ Sondes (devices that measured temperature, conductivity, and turbidity in water column of runoff) were installed at two of the sites to analyze the runoff for temperature, conductivity, and turbidity during runoff. In addition, a rain gage was installed at two of the three sites to record rainfall accumulation every 15 minutes.

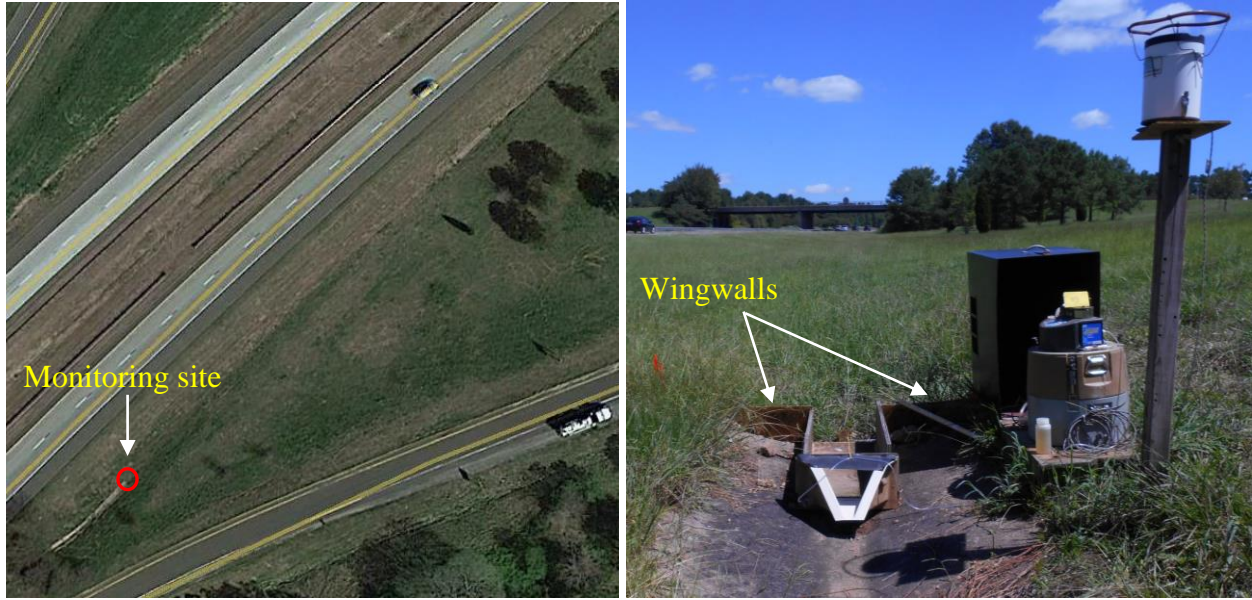
Figure 4. Site 204A aerial view (left) and monitoring station (right).

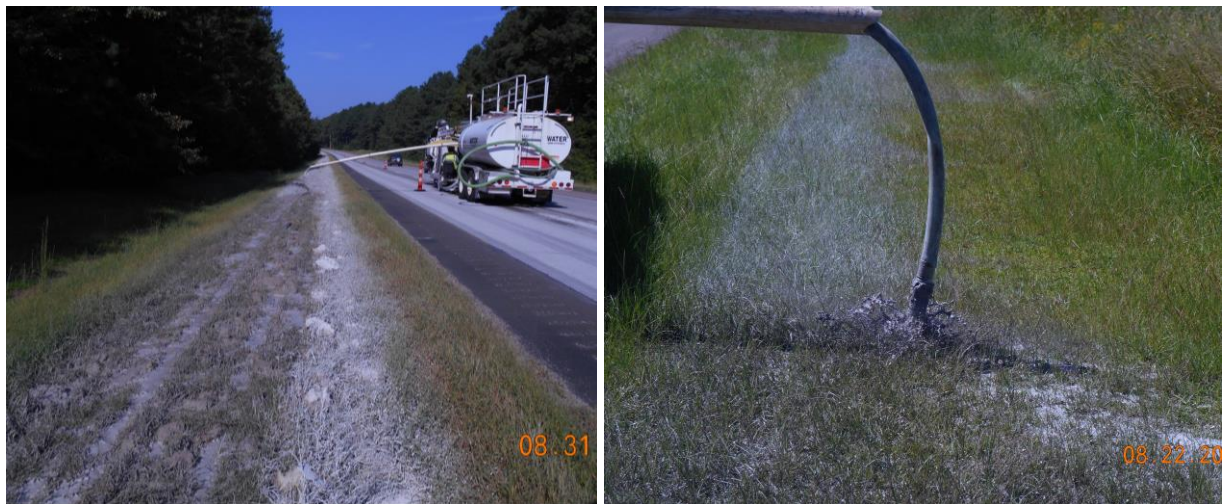
Figure 5. DGS on furrowed shoulder (left) and DGS discharge from grinding machine (right).

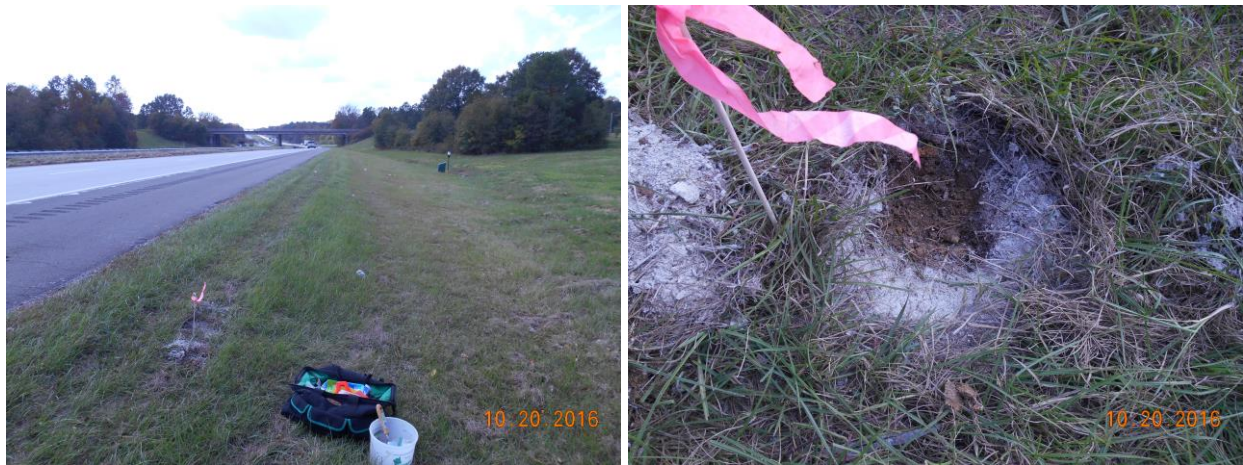
Figure 6. Soil sampling location on shoulder (left) and sampling hole with DGS cleared (right).

Soil samples were collected from the top 2 inches of the soil layer on shoulders and exit ramps along I-85 prior to DGS application. Soil samples were also collected from the top 2 inches of the shoulders after DGS application (figure 6). These samples were collected 3-4 ft out perpendicular from the edge of the road surface at 2-3 locations along about a 50 ft section of the shoulder and combined to make 1 sample for analysis. This was repeated along another 50 ft section of the shoulder where DGS was applied in the pilot sites. Samples were collected directly below the aforementioned sample sites at a depth of greater than 2 inches. Particular care was taken to prevent observed DGS solids from being collected as part of the soil sample. Soil samples were also collected about 8 ft directly downslope from the shoulder samples, but not in roadside ditch bottom itself. All soil samples were sent to the Waypoint lab for analysis. Photodocumentation and observation of vegetation on the shoulder will also be conducted.

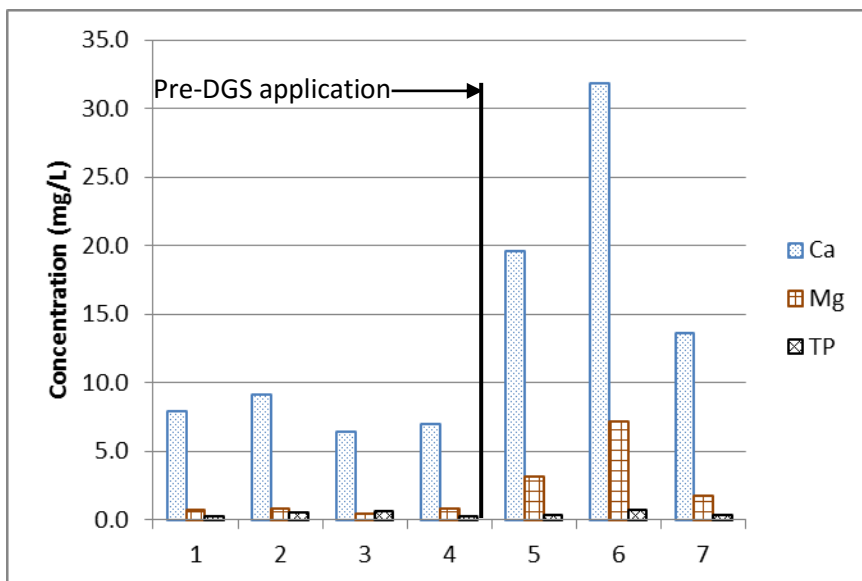
Figure 9. Concentrations of Ca, Mg, and TP in runoff samples from site 204C.

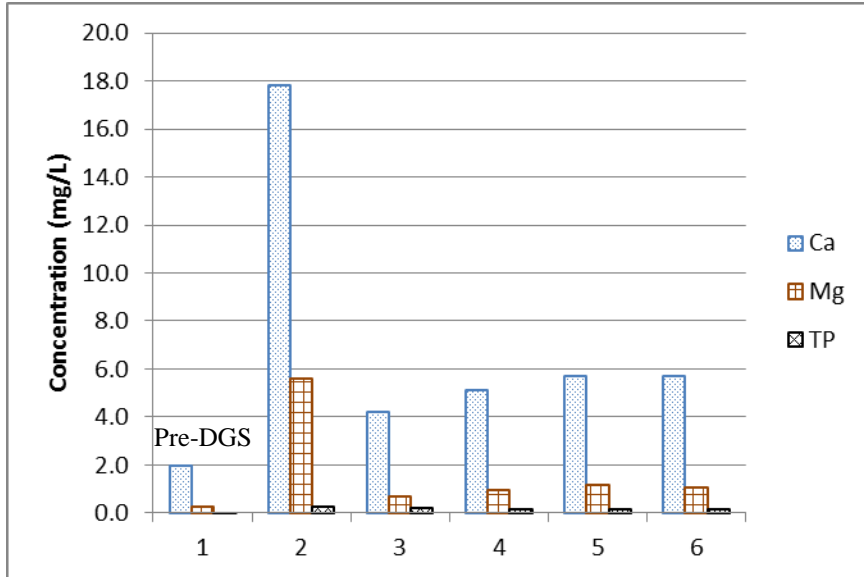
Figure 10. Concentrations of Ca, Mg, and TP in runoff samples from site 206D.

Runoff volume and quality for Site 206D are shown in Table 4. Only 1 storm occurred prior to DGS application so there is no pre- to post-DGS comparison. Runoff from the first storm after DGS application (#2 in figure 10) had the highest concentrations of Ca and Mg. Subsequent storms had elevated concentrations of Ca and Mg in runoff compared to the runoff from the pre-DGS application storm, but not nearly as great as the first event. The first storm after DGS application was intense (Peak 30-min. rain= 0.5 in/hr), but had relatively low overall runoff (Table 4), which combined to produce the highest concentrations of Ca and Mg in runoff. The first storm after DGS application has lots of available DGS on vegetation and other surfaces which is easily transported in runoff. Observation documented that most of the DGS was in the small furrows left by the vertical tillage tool on the contour of the shoulder. The TSS concentration in runoff was relatively low, which was unexpected as the tillage disturbed the soil surface. However, the disturbance was not enough to break up the root mass of the vegetation which held the soil in place.

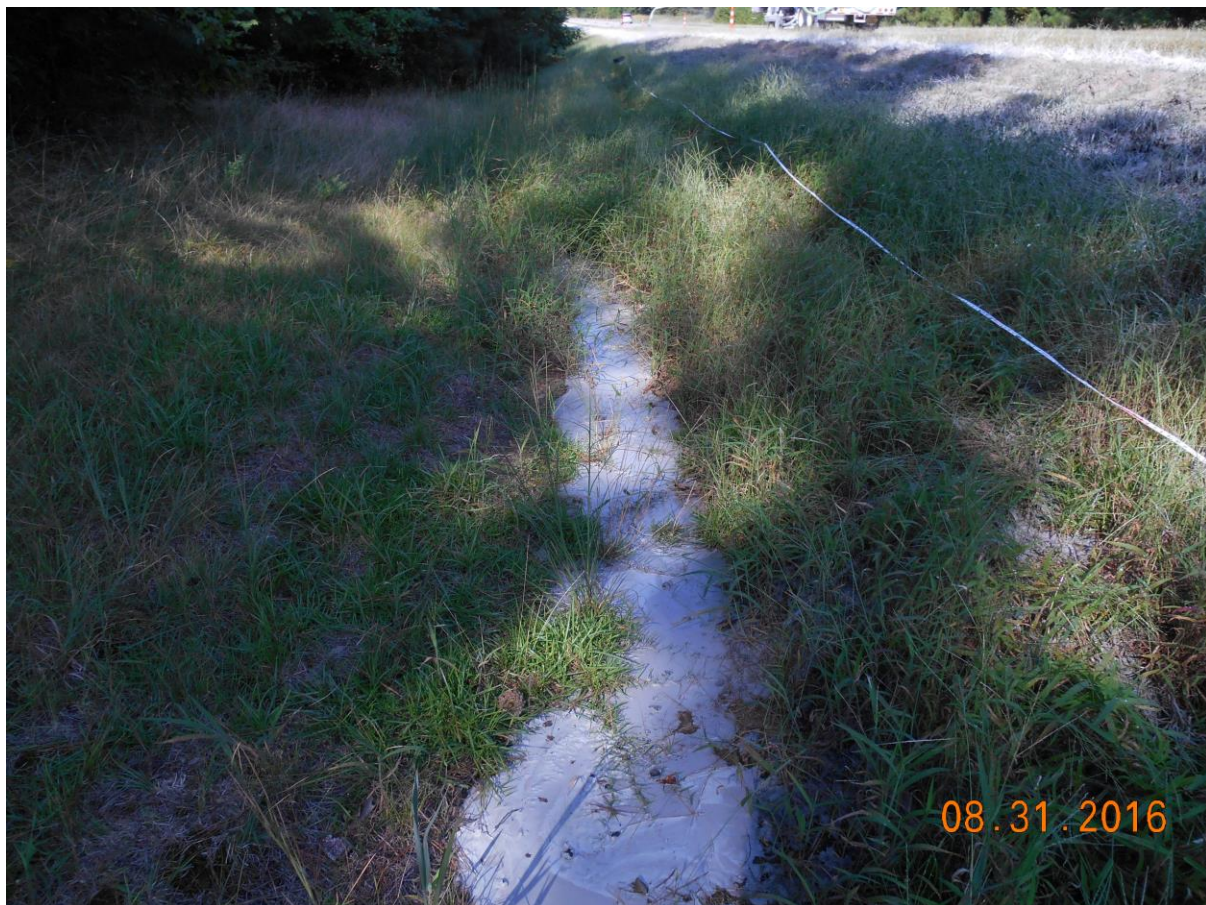
Figure 10. DGS in roadside ditch flowing towards woods.

Observation of DGS application to shoulders showed that, for the most part, the DGS stayed on the shoulder and did not run down into the ditches or offsite immediately after application. The fact that the ground was relatively dry and the shoulders well vegetated during the application certainly helped. This also helped prevent the DGS from being transported in runoff. However, there were places where the DGS flowed a considerable distance immediately after application. One such place is shown in figure 10. At this location, the vegetation was relatively light and the shoulder to the median narrow so that during application DGS flowed into and down the roadside ditch and was observed flowing into the woods. This location was in the median and there was a wooded buffer so it is unlikely the DGS reached and surface water; however, certainly runoff from subsequent storms could wash a considerable amount of the DGS into an adjacent stream. There were several other places where the DGS flowed 1-3ft down the slope of the vegetated shoulder, but then stopped. It is uncertain how far solids in this DGS would be transported by runoff. Hence, there may be project locations where collecting and hauling, at least some, of the DGS may be necessary. For this section of I-85, several locations within the exit and on ramps appeared to be suitable for land application of DGS, so hauling distances could be reduced. A set of conditions for highway shoulders (i.e. slope steepness and length of shoulder, proximity to stream, density of vegetation, soil type, and area of shoulder compared to drainage area), could be developed as a Best Management Practice (BMP) which would determine the potential for direct-discharge of DGS with the rest of the generated DGS being hauled to a nearby area for land application.
