EXPERIMENTAL PROJECT: ENHANCED DRAINAGE BY USE OF PAVEMENT GROOVING INTERSTATE 295 NORTH

June 2007

Federal Highway Administration
and
Rhode Island Department of Transportation

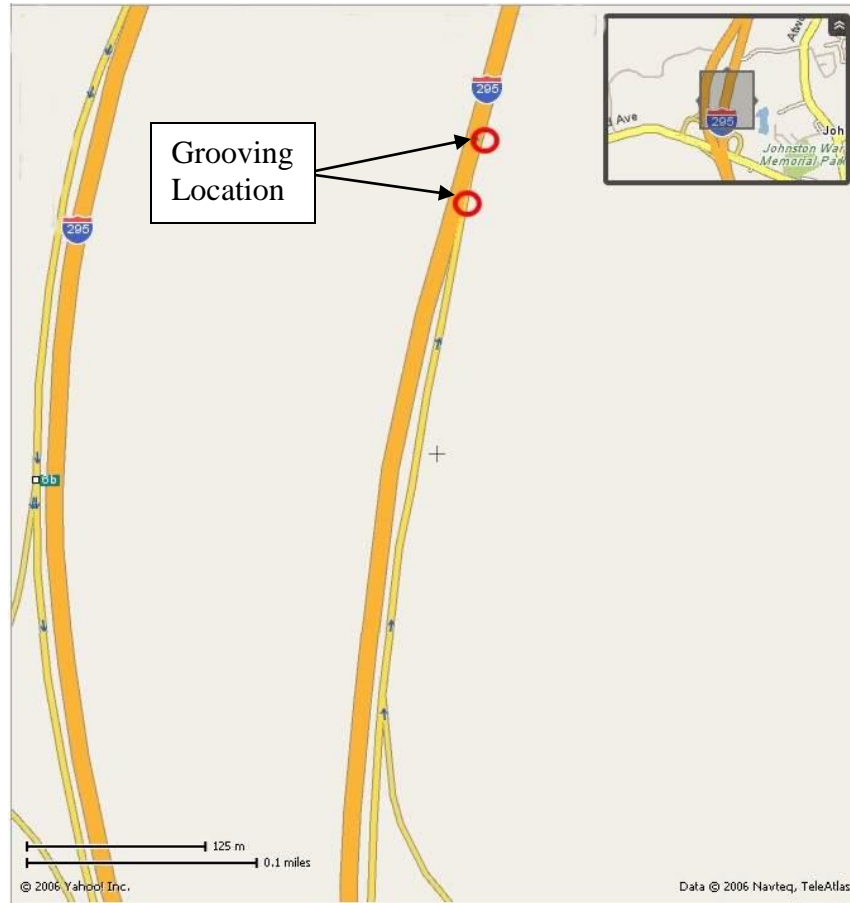
Figure 2 – Pavement Drainage Grooving Location

A test section was selected on I-295, which includes a section of the on-ramp just prior to the merge and a section shortly after the first, including the merge (see Figure 2). This area was selected because of a higher than normal incidence of accidents, particularly for a straight section. The width of the pavement makes carrying water off to the shoulder problematic. As a result, water stays longer in the travel lanes and creates the potential for issues with hydroplaning and black ice formation. The pavement will be overlaid with friction course during the next construction season, so repairs will not be required once the study is complete. The grooves have been put into place prior to the winter season, to observe the effects of the plow blades.

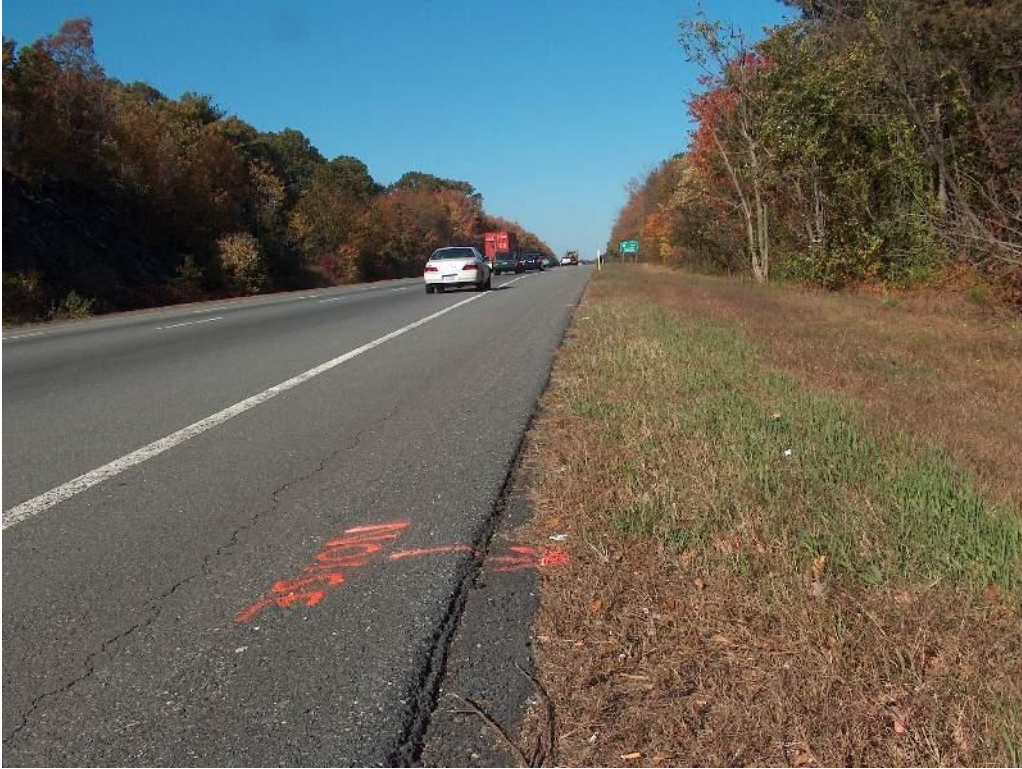
Figure 3 – Prior to Grooving

The following photos (Figures 3 through 8) demonstrate pre- and post-grooving conditions (Figure shows the grooves as they are being cut). Figure 9 plots the sound levels over the same time period (hour of the day) before and after the grooving.

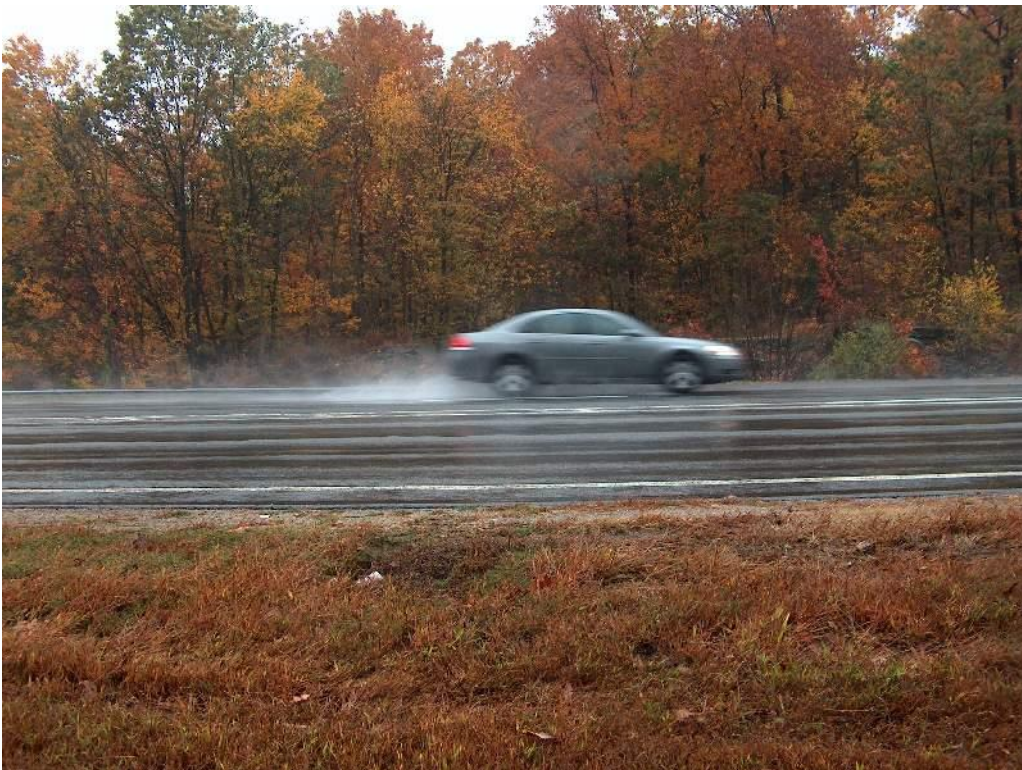
Figure 4 – Prior to Grooving – Light Rain (note misting behind tires)

There appeared to be reduced misting from the tires in the post-grooved section, although rainfall, tire weight, tire design, ambient temperature and other factors may have contributed over the two different days. Water did not seem to collect in the area around the grooves (see Figure 7). This can be seen more clearly in Figure 8. Note that while there is water before the grooves (the leading edge), the space between and after the grooves is dry. The inset shows water flowing off the end of the grooves. Note that the grooves end where the shoulder meets the low speed lane

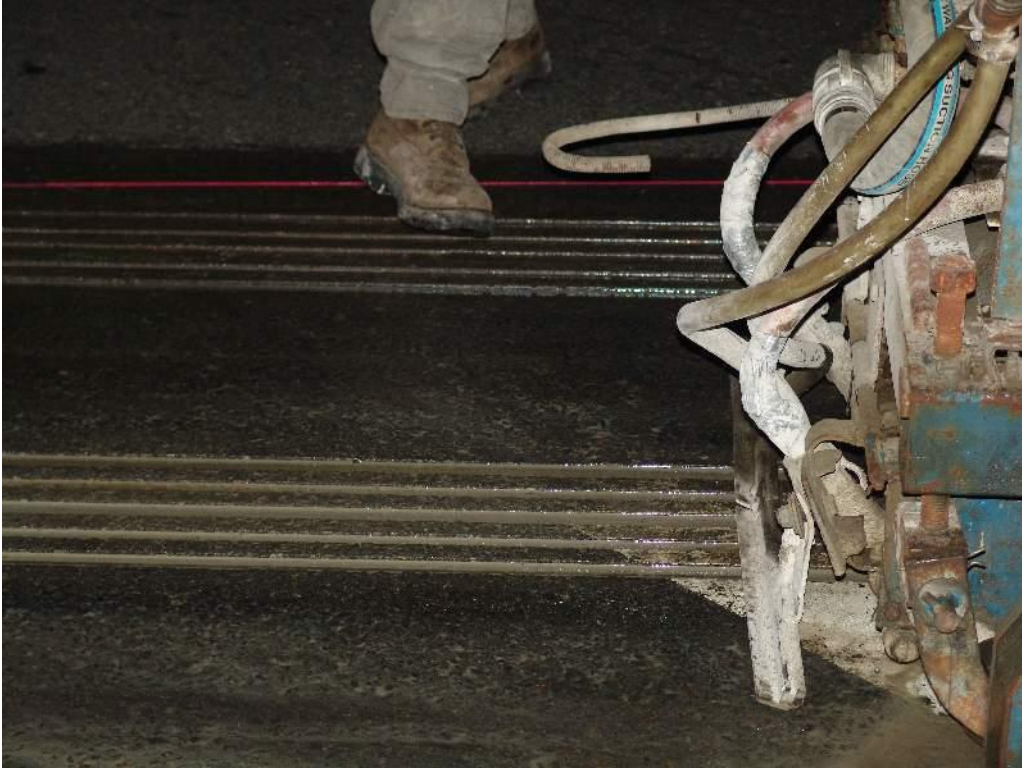
Figure 5 – Groove Cutting Equipment and Process

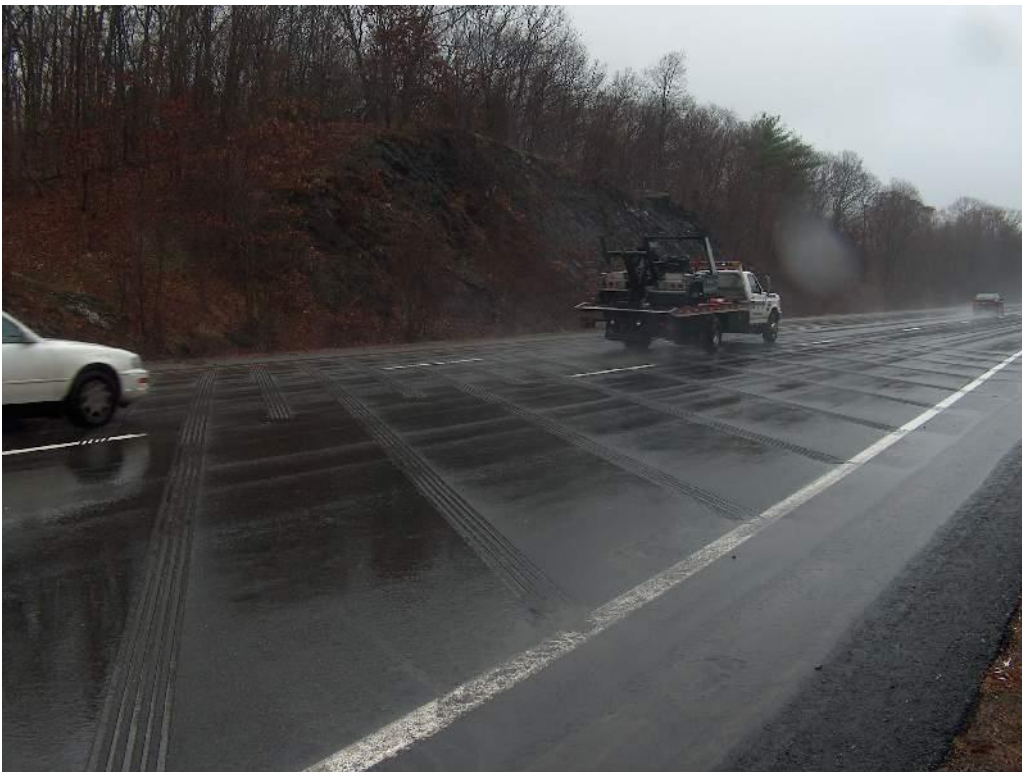
Figure 6 – Grooved Pavement – Moderately Heavy Rain Event (reduced misting behind tires)

The observed reduction in the misting trail from the tires is subjective, although shared by several individuals. It does create the sense that the grooves may enhance drainage from the roadway, which is the intent of the system. Further testing would be necessary and would require a more planned and involved experimental approach. However, the images taken during rain events clearly show that the grooves re-direct and drain water to the shoulder.

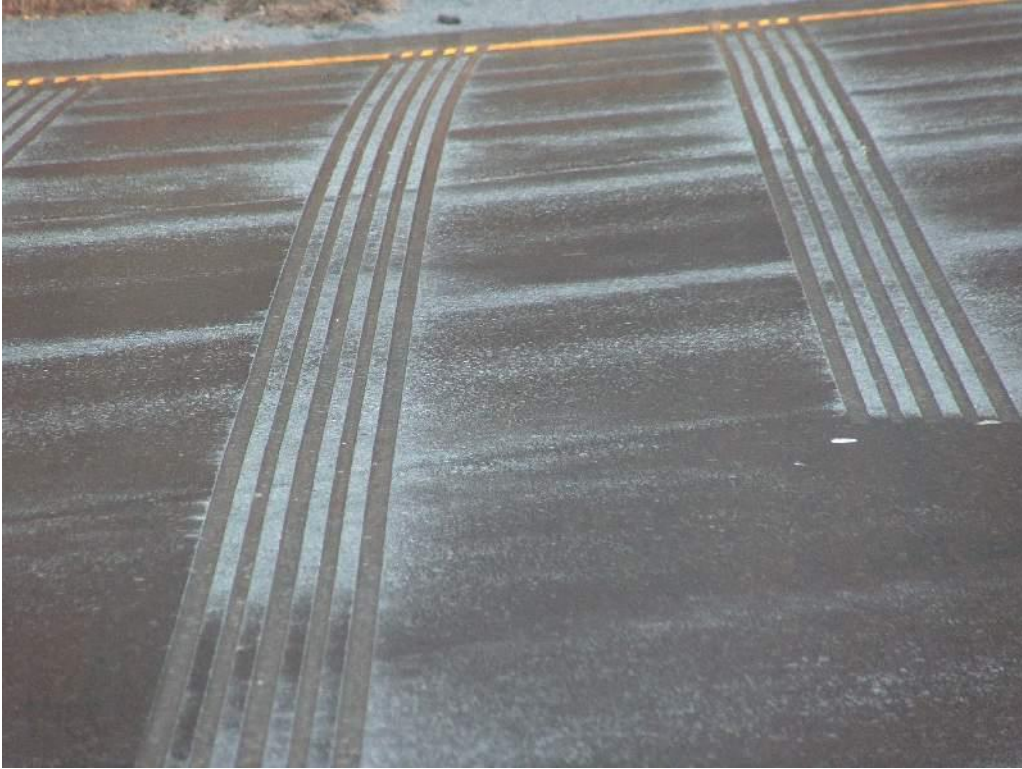
Figure 7 – Close View of Groove Patterns During Moderately Heavy Rain Event

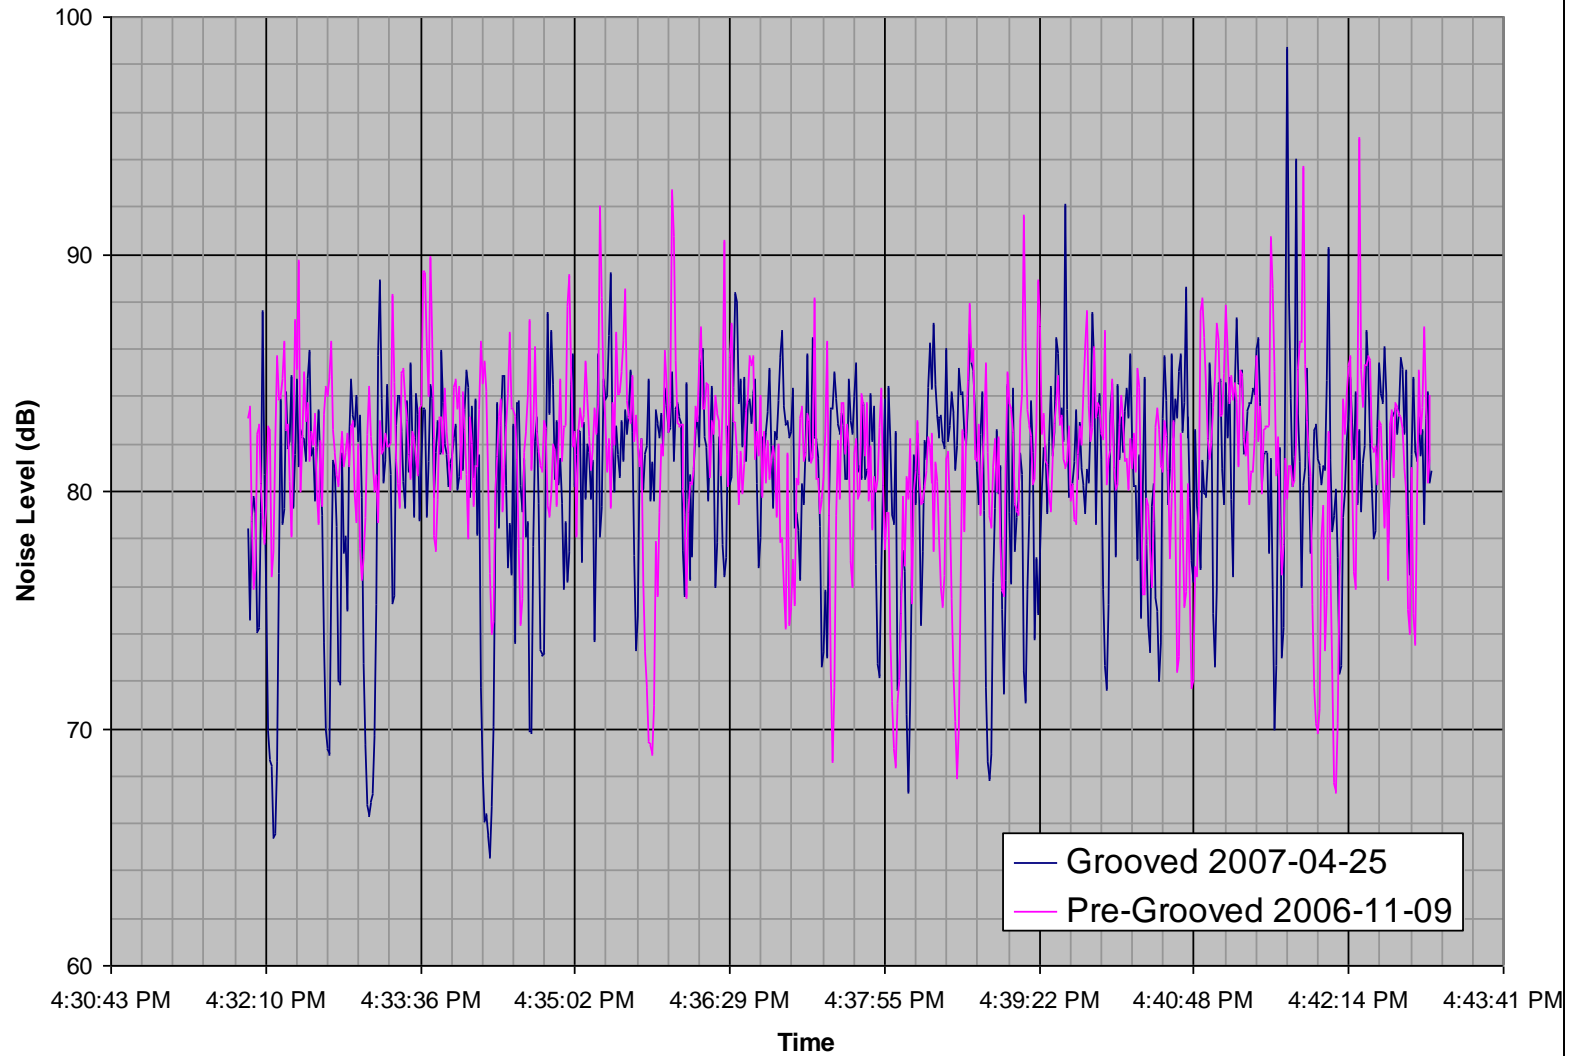
I-295 Grooved Section Comparative Effect on Noise Levels

Pre-Grooved: 83.4 dB Avg, 67.3 dB Min, 94.9 dB Max

Grooved: 80.5 dB Avg, 64.6 dB Min, 98.7 dB Max

The measured noise level was actually lower after grooving (see Figure 8), but without a more rigorous and detailed experimental setup to reduce variables, it should be stated conservatively that the process had minimal impact on the tire noise. One observer who travels the road regularly with a personal vehicle noted that the ‘on/off’ tire noise (created

Both objectively and subjectively, the grooving appears to have little impact on the noise levels, although it does seem to shift it towards the higher frequencies. This may account for the reduced average level for the grooved pavement, since the meter readings were weighted. Weighting emphasizes some frequencies over others to match the tendencies of human hearing. The ear is most sensitive to the mid-range (2,000 – 4,000 Hz) and increasingly less sensitive as the pitch rises (most adults can hear little above 10,000 Hz). Higher frequencies also do not carry as far as lower ones, which would reduce relative levels at the side of the road (where the meter was placed).

It may also be that the conditions were simply different on the days of the measurements. In any case, the 3 dB difference would hardly be noticeable to most people. The difference in the peak levels is also relatively small and is probably more a function of vehicle noises other than tires on the pavement.
