## TECHNICAL NOTE

TECH NOTE NO: 28  
TITLE: Performance of Grooved Bituminous Runway Pavement  
AUTHORS: Alex K. Apeageyi, Imad L. Al-Qadi, Hasan Ozur, and William G. Buttlar  
CONTACT: University of Illinois, Dept of Civil & Environmental Engineering  
1212 NCEL, MC-250, Urbana, IL 61801, PH (217) 333-5966,  
Email: [buttlar@uiuc.edu](mailto:buttlar@uiuc.edu) and [alqadi@uiuc.edu](mailto:alqadi@uiuc.edu)  
DATE/REV: 04/06/07

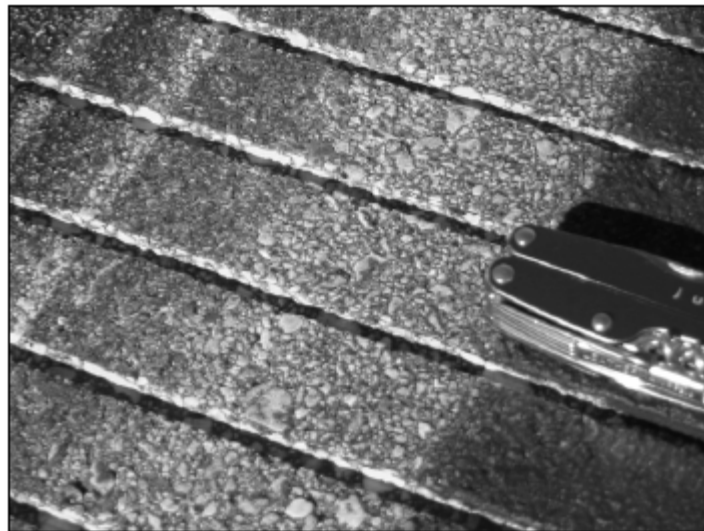
**Figure 2** Five-year old saw-cut grooves at Volk Field Air National Guard Base in Wisconsin; the HMA runway regularly supports heavy cargo planes (4)

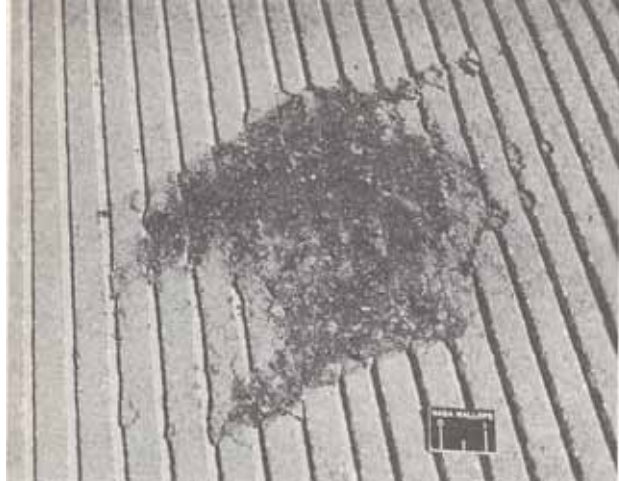
**Figure 5** Damaged grooves by Convair 990 during 180 ° turns at Wallops Facility (3)

Wear, closure, and migration can lead to groove collapse. Allen and Quillen (3) evaluated the effects of aircraft loading and climatic conditions on the performance of grooved HMA runways. Tests were conducted on an 8750-ft-long runway at NASA's Wallops research facility. The grooves were  $\frac{1}{4}$ -in-deep by  $\frac{1}{4}$ -in-wide and spaced at 1-in centers. Two HMA mixtures identified as small aggregate HMA ( $\frac{3}{8}$  in nominal maximum aggregate size); and large aggregate mixtures ( $\frac{3}{4}$  in nominal maximum) were used. Repeated aircraft loadings (McDonnell Douglas F-4D and Convair 990) were applied on the grooved pavements. The study reported unsatisfactory performance of the transverse grooves; especially in areas where the Convair 990 aircraft made  $180^\circ$  turns. The study identified the following problems with HMA grooves: i) grooves were destroyed during  $180^\circ$  turns, as shown in Figure 5; and ii) in the large aggregate HMA sections, the  $\frac{1}{2}$  and  $\frac{3}{4}$  in aggregates tended to break loose from the grooves and pose foreign object damage FOD danger. The study recommended that grooving should be performed only in HMA with aggregates less than  $\frac{3}{8}$  in.
