# partial depth repair (PDR)

*Partial Depth Repair Restores Rideability, Alleviates Further Deterioration*

Partial Depth Repair is a Vital Tool in the Concrete Pavement Preservation (CPP) Toolbox

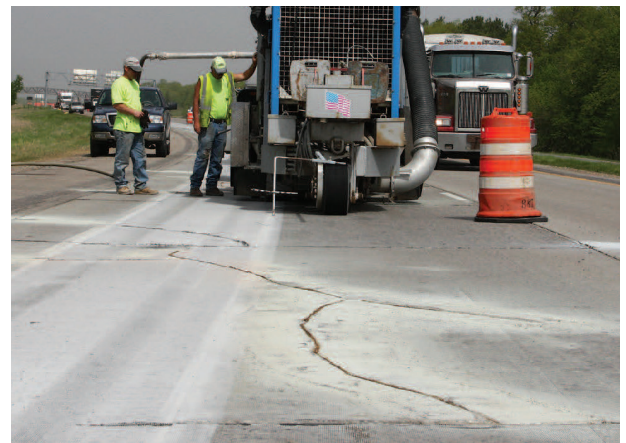
An alternative method involves the use of milling equipment to remove the deteriorated concrete. This method is allowed by specification in Minnesota, Wisconsin, Michigan, Missouri and Kansas and has been used in these states with much success. Milling is a very cost-effective and efficient method when used on projects with a large amount of surface spalling. As an example, removal of deteriorated concrete along a 15-foot crack takes less than 10 minutes with a mill. Removing this same deterioration with a saw and jackhammer typically takes between 45 to 60 minutes. The Minnesota specification calls for a minimum removal depth of 2 inches with a tapered milling head measuring 10 inches at the bottom and 12 inches at the top to leave a tapered edge for the completed patch dimensions. This procedure has had tremendous success as evidenced by decades old PDRs still in service in Minnesota.
