# CPR – REBUILT TO LAST

## Salt Lake City Concrete Pavement Restoration

### >>> PATCHING, DIAMOND GRINDING & JOINT RESEALING

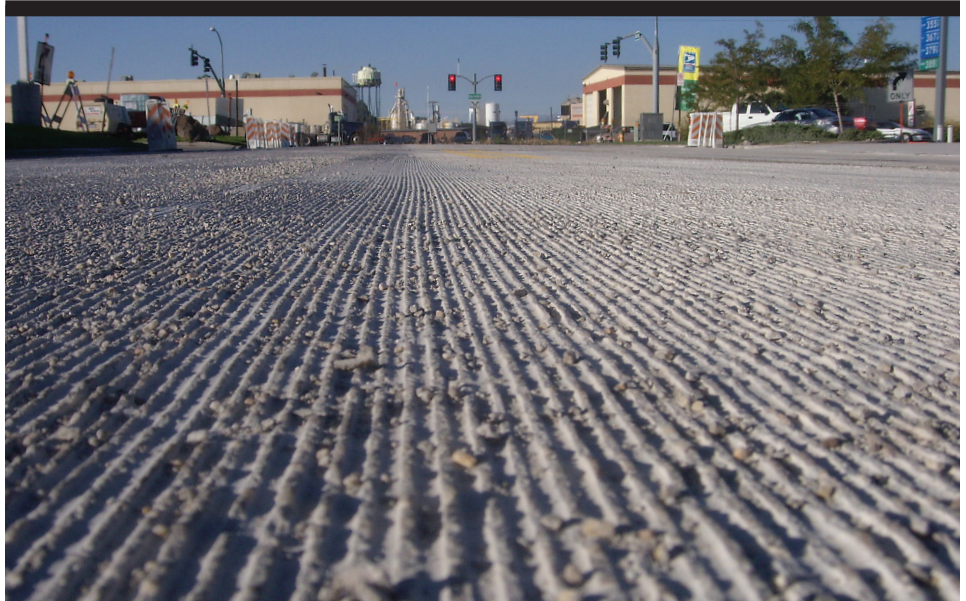
This design engineer decided to test an innovative new crack stitching procedure utilizing polyurethane material and fiberglass panels. The

Uretek Stitch-In-Time process was selected and used beneath five slabs that contained minor cracks. Following the slab stabilization and lifting operations, the Stitch-in-Time process required the placement of ½ inch fiberglass panels (stitches) within saw cuts made perpendicular to the slab crack. The cuts were then filled with clean pea gravel and an acrylic bonding material was poured into each cut. Four stitches were placed in each candidate slab.

Following the stabilization, lifting and stitching operations, the retrofit dowel bars were installed in the slabs, severely cracked slabs were removed and new concrete was placed in the necessary areas. Once the concrete was fully cured, the entire area was diamond ground to remove remaining surface defects, increase smoothness and provide a safe, high friction wearing surface. The joints between the slabs were then cleaned and resealed to prevent the intrusion of water and incompressible materials. As a final step, a sealing compound was applied to the concrete surface to provide additional protection.
